# Inspection Report - Non Invasive

**Safehome PTY LTD**

**1 Smith St, Pennydale, VIC, 3192**

Report/Agreement #	2305230921506
Inspection Date:	23 May 2023
Inspection Time:	11:00 am

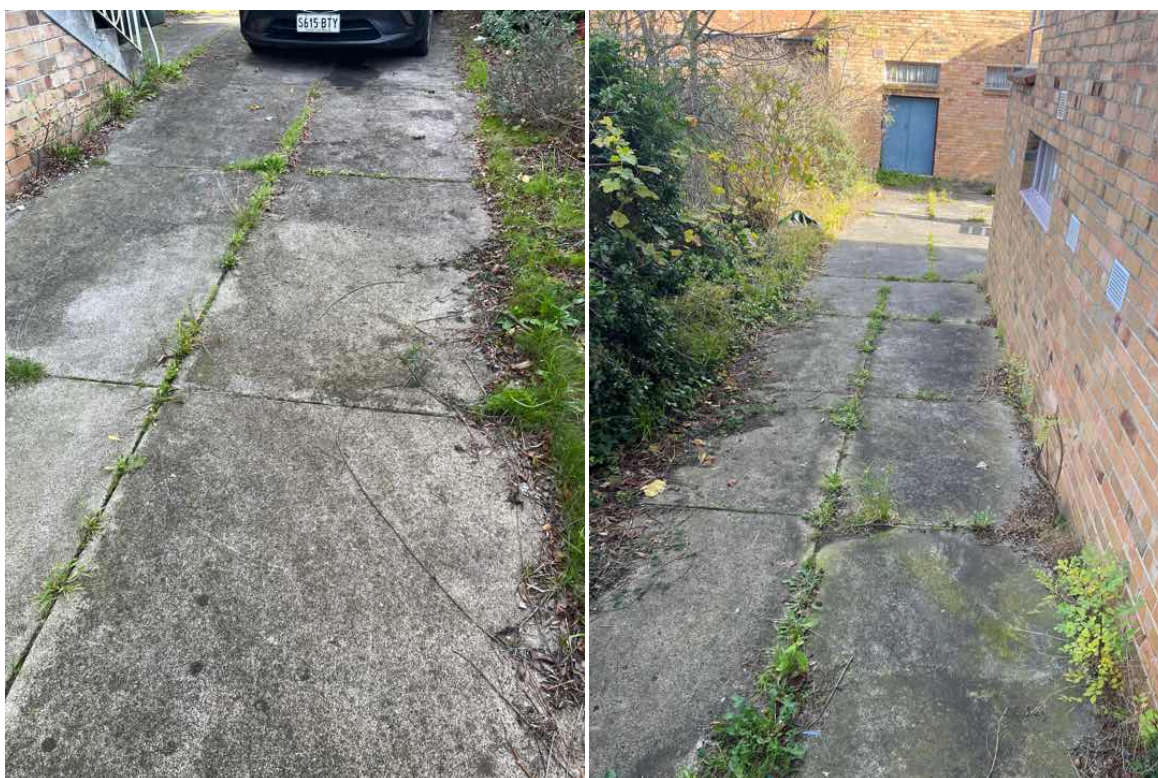
Driveway has visible tripping hazards in sections. Repairs are required by a qualified concreter to avoid potential injury.

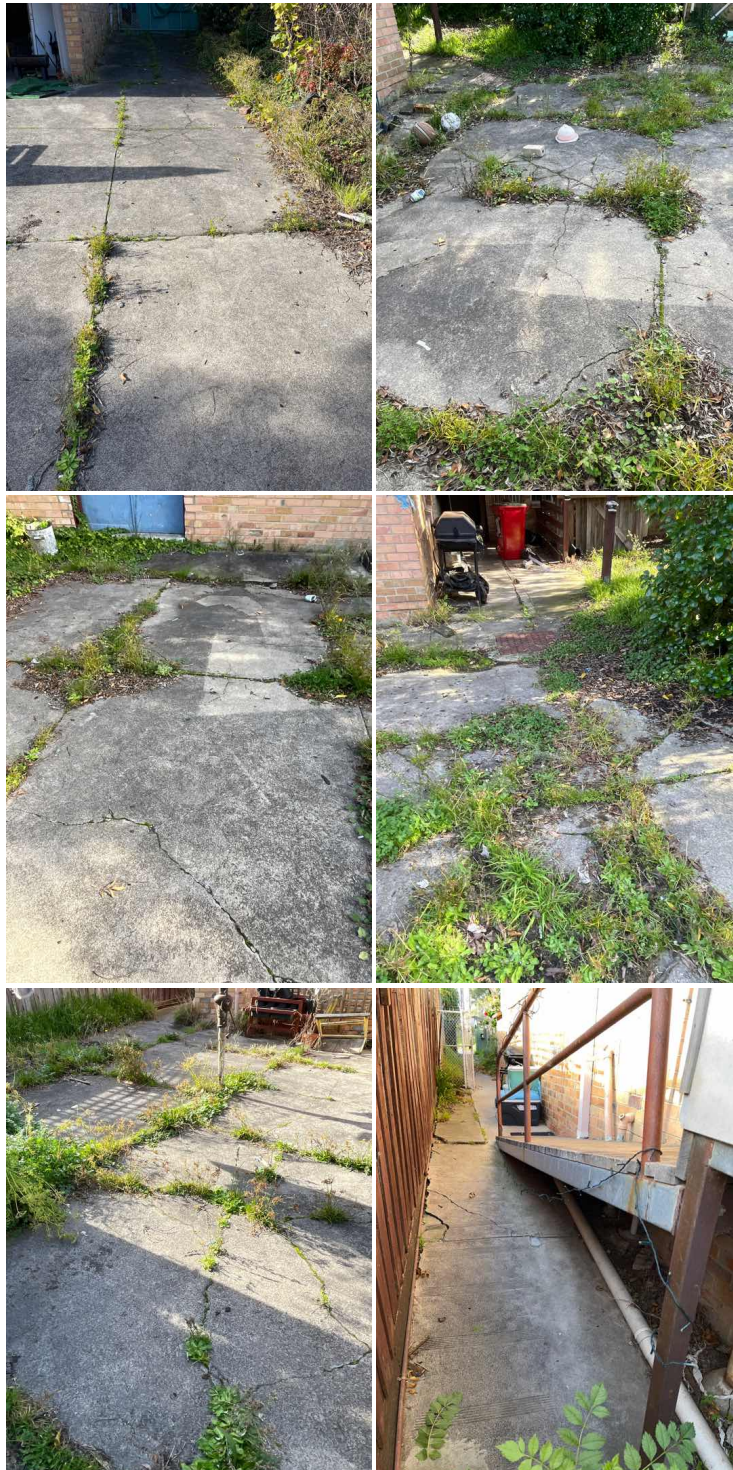
The driveway is in poor condition & replacement by concreter recommended.

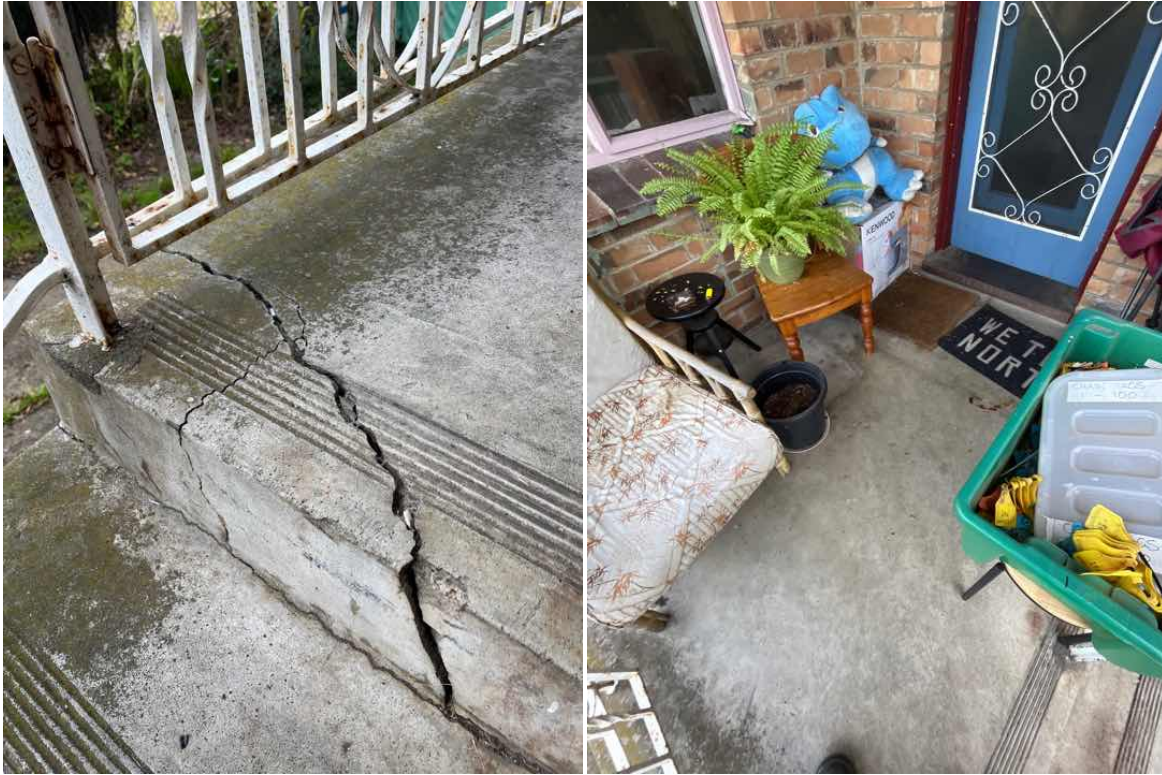
The entry area concrete slab has subsided/dropped/large cracks. This is often observed in older homes due to poor footing construction - Engage a qualified concreter to assess/repair.

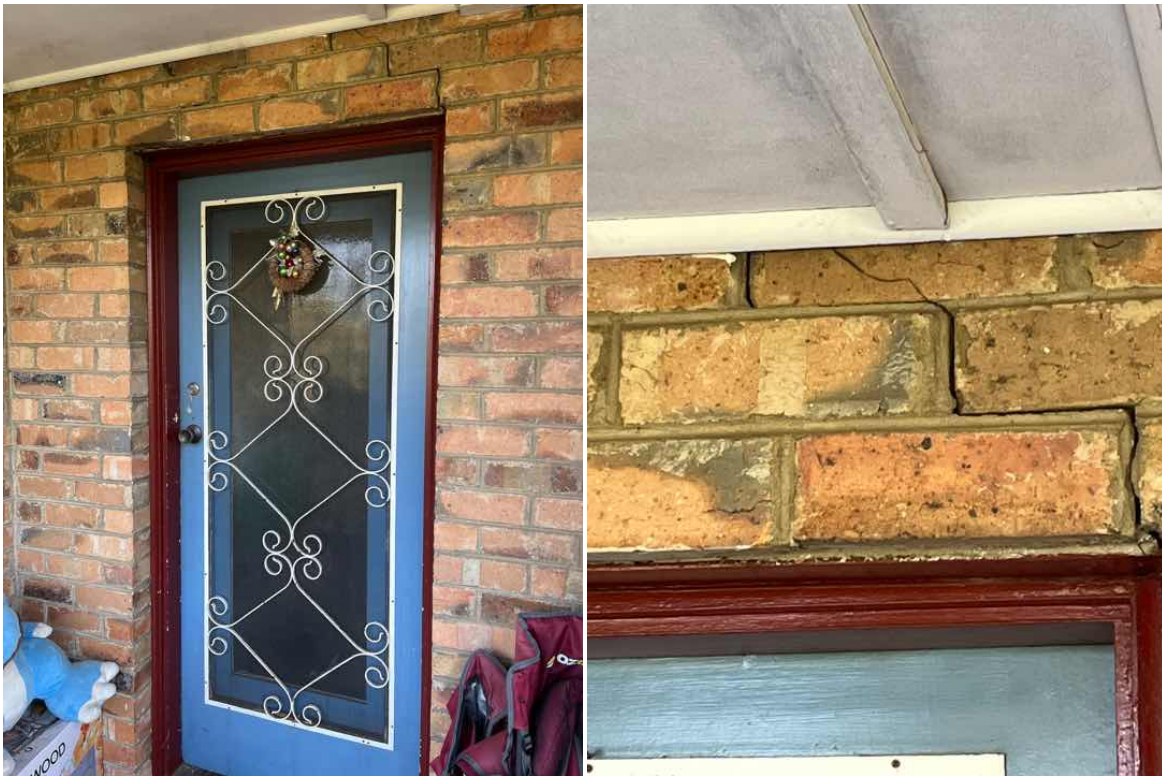
Settlement cracks in areas. Monitoring for 12 months advised & if widening subsequently occurs it will require assessing by a structural engineer or brick layer.

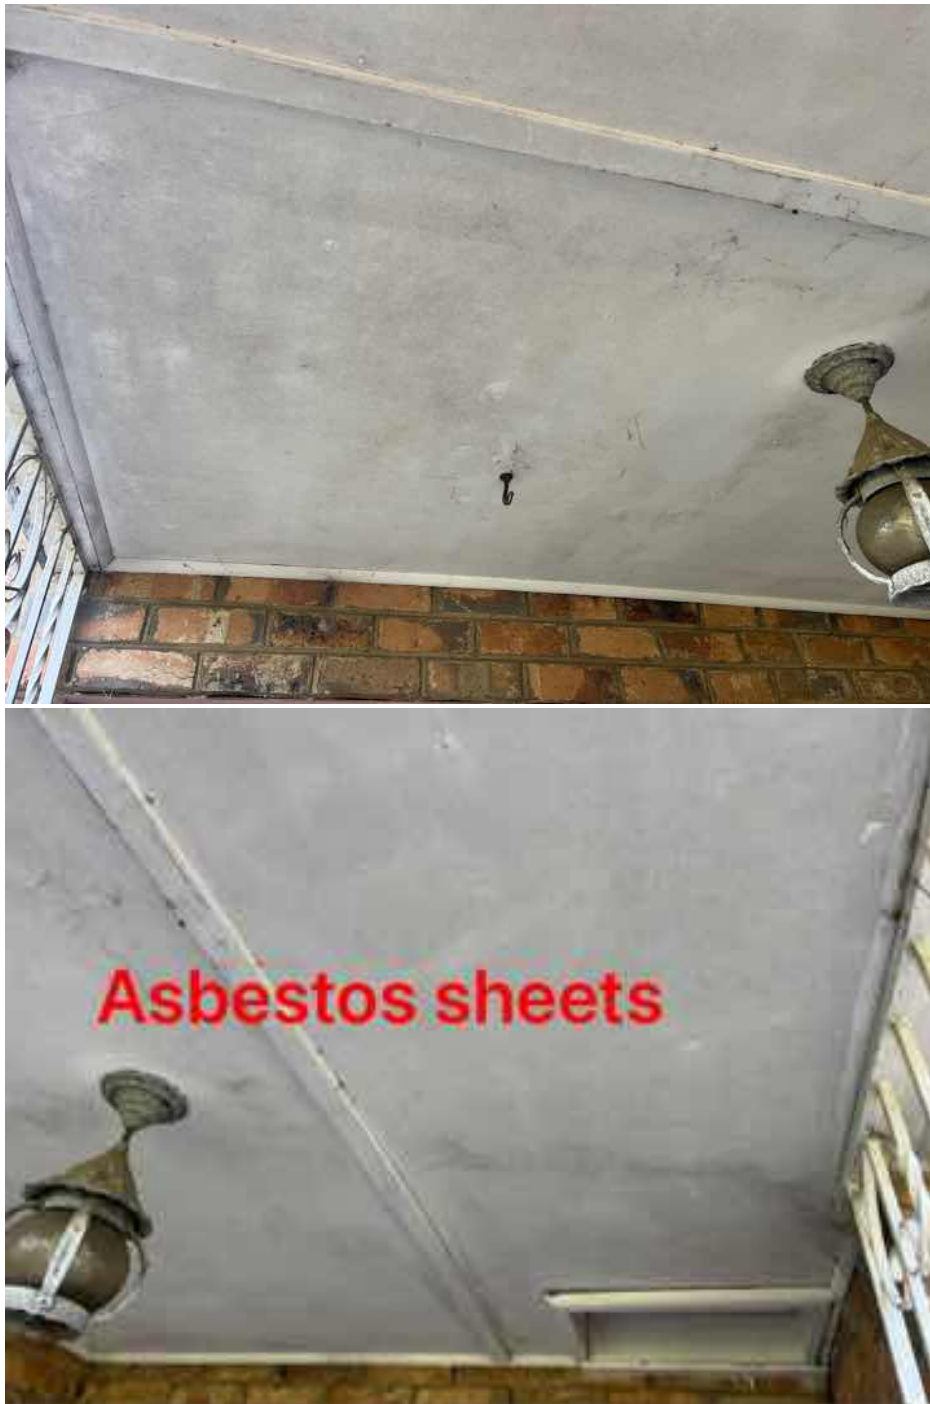
Paint on lining has deteriorated in areas. Have prepped and painted.

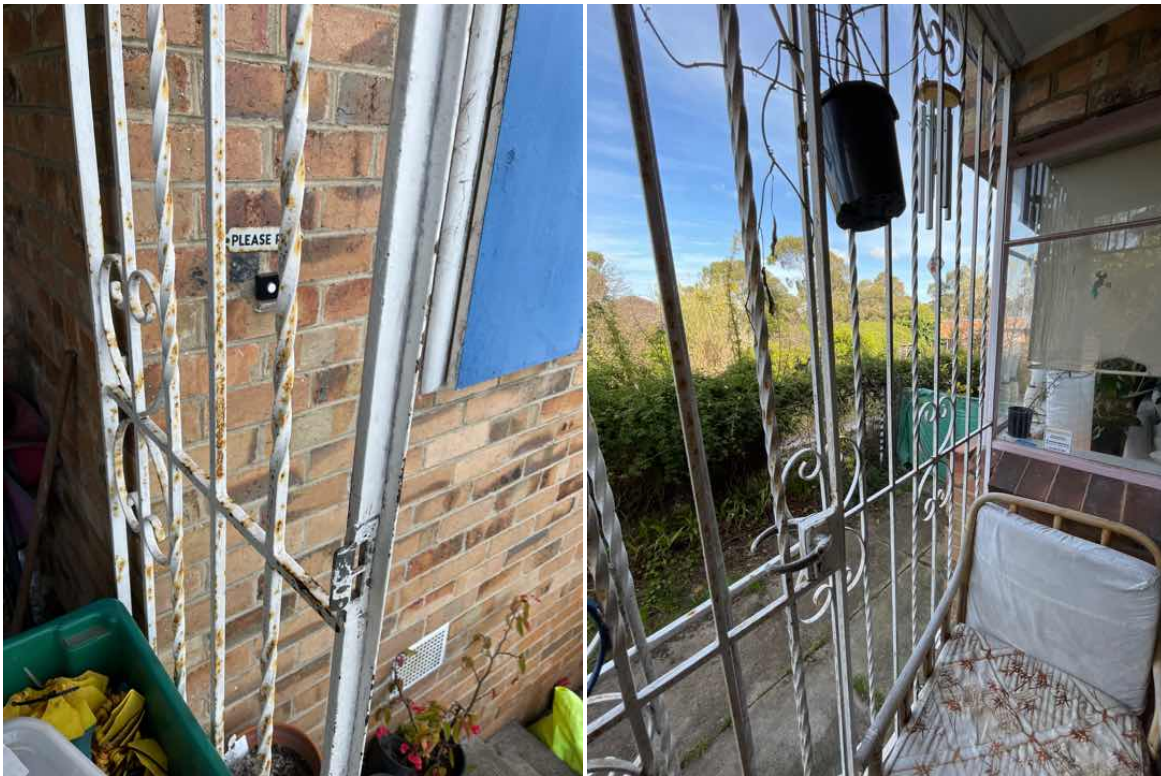
Rust deterioration evident on sections of posts/components - Engage a qualified trades person to assess with view of restricting / repairing the rust.

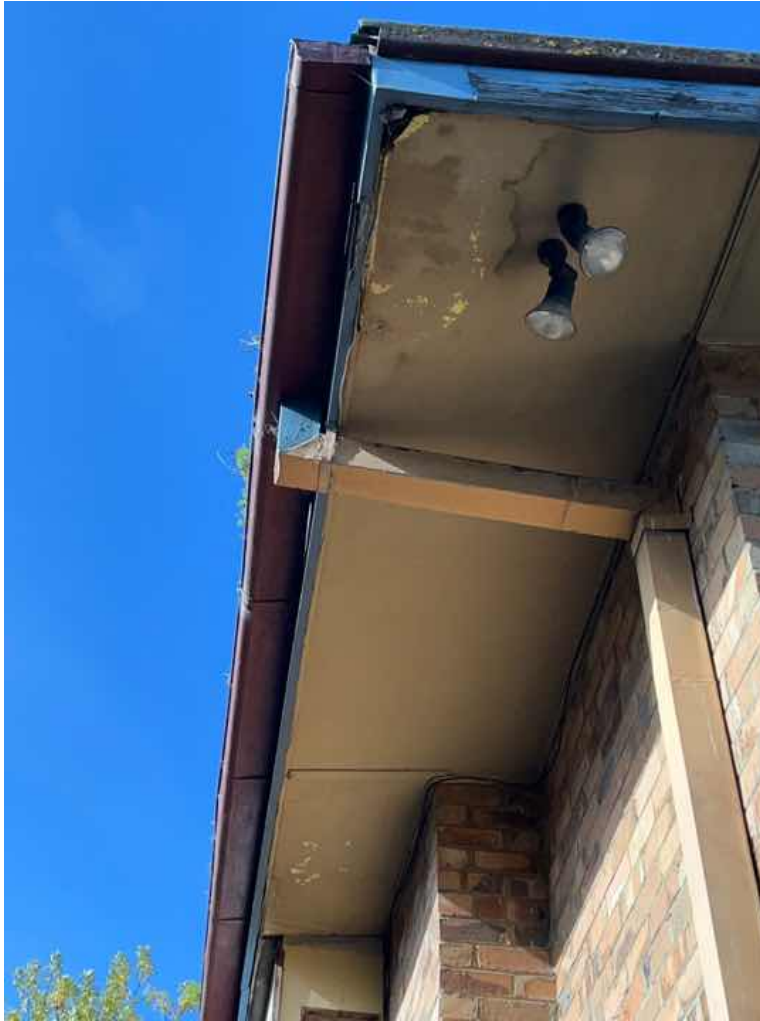
Gutter surface rust in sections - replacement recommended in near future.

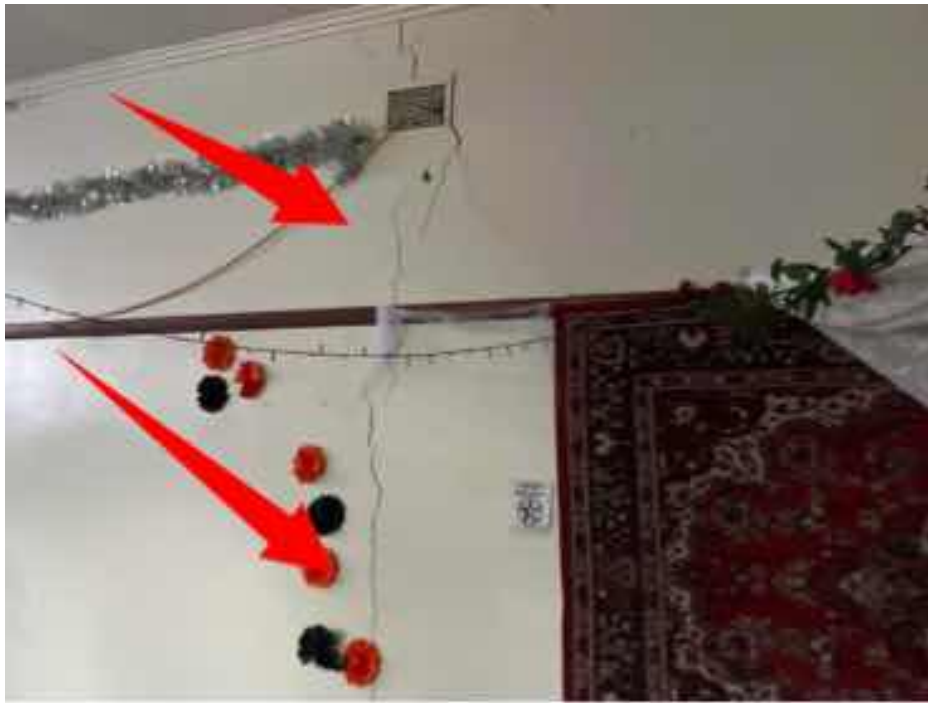
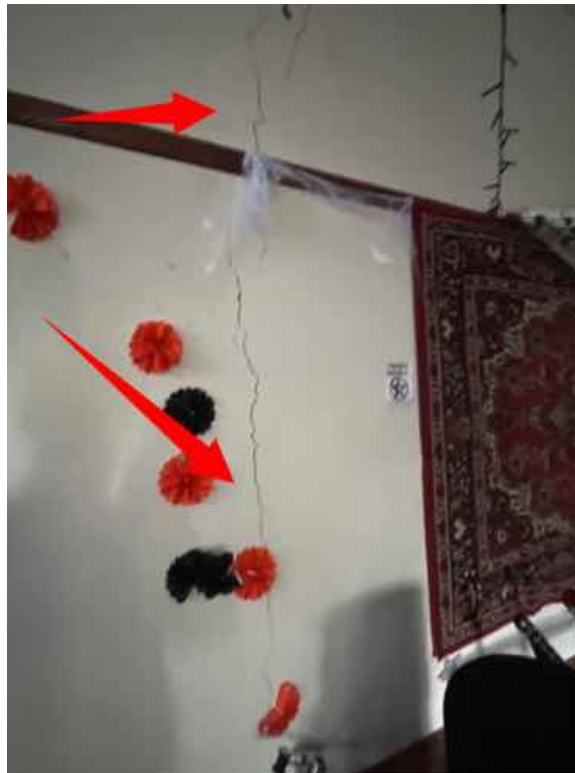
Old damp damage to wall. Tested and dry today. Repairs by a plasterer recommended.

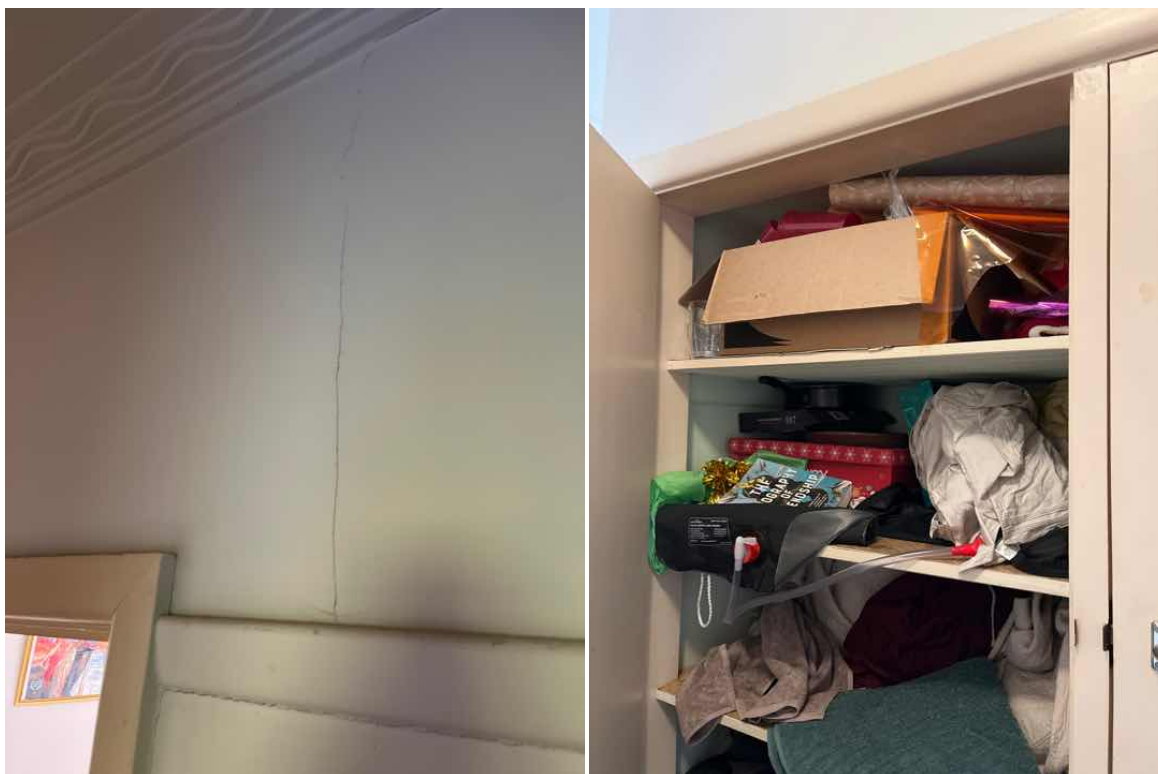
Settlement Cracks on wall areas. This can be related to differential settlement in footings, shrinkage in timber framing or poor plastering. Monitoring these cracks for 12 months is advised & if become wider or longer, you will need to contact a structural engineer to assess.

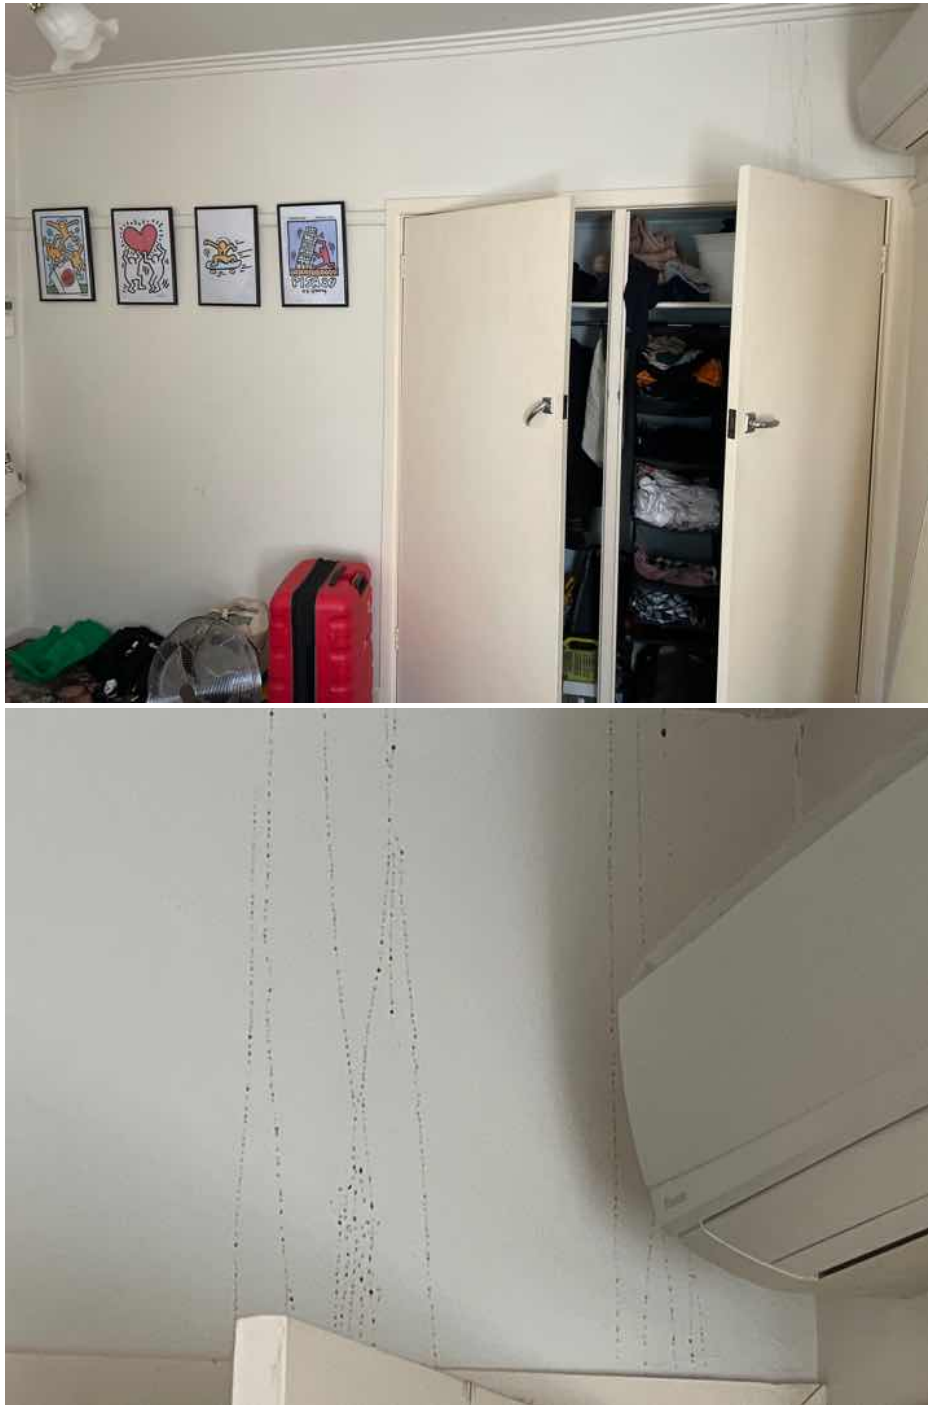
Old damp damage to wall. Tested and dry today. Repairs by a plasterer recommended.

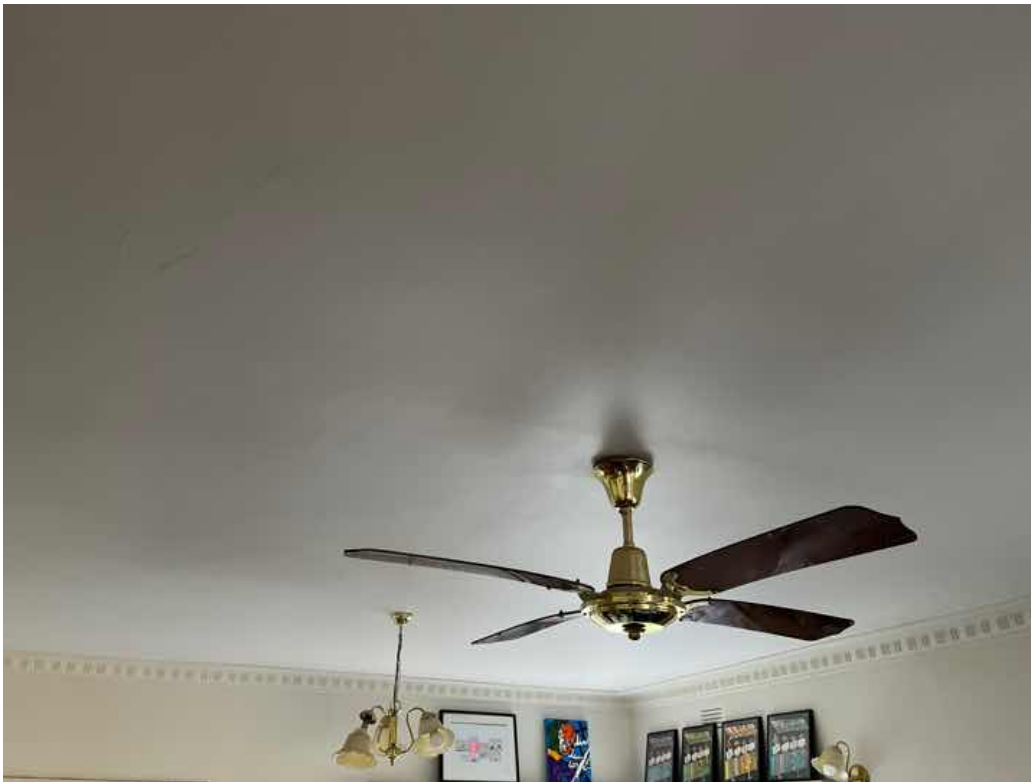
Uneven ceiling sections. Have plasterer assess.

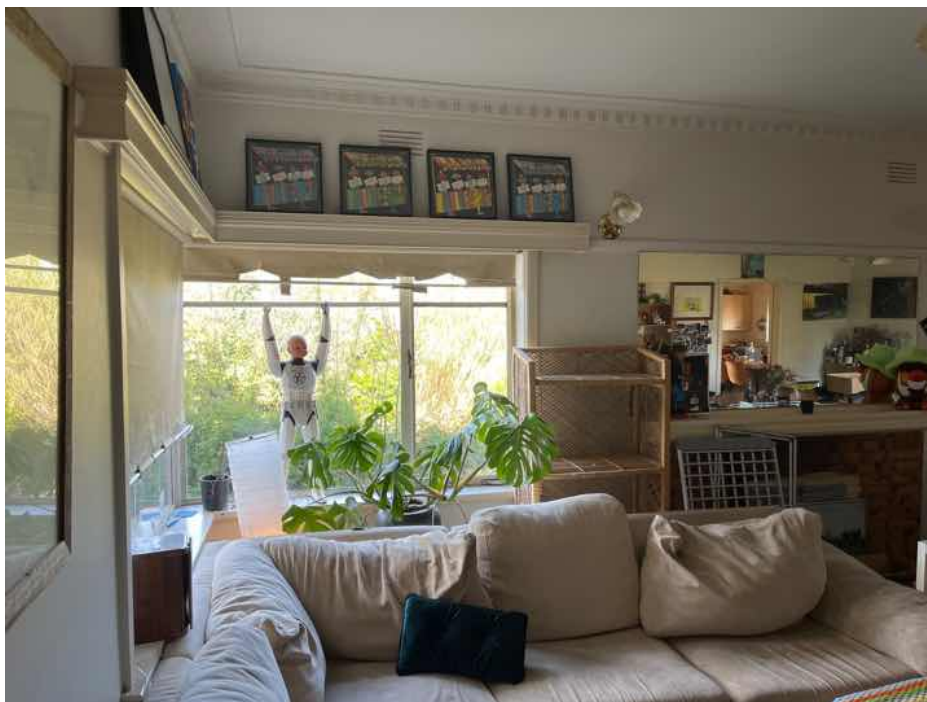
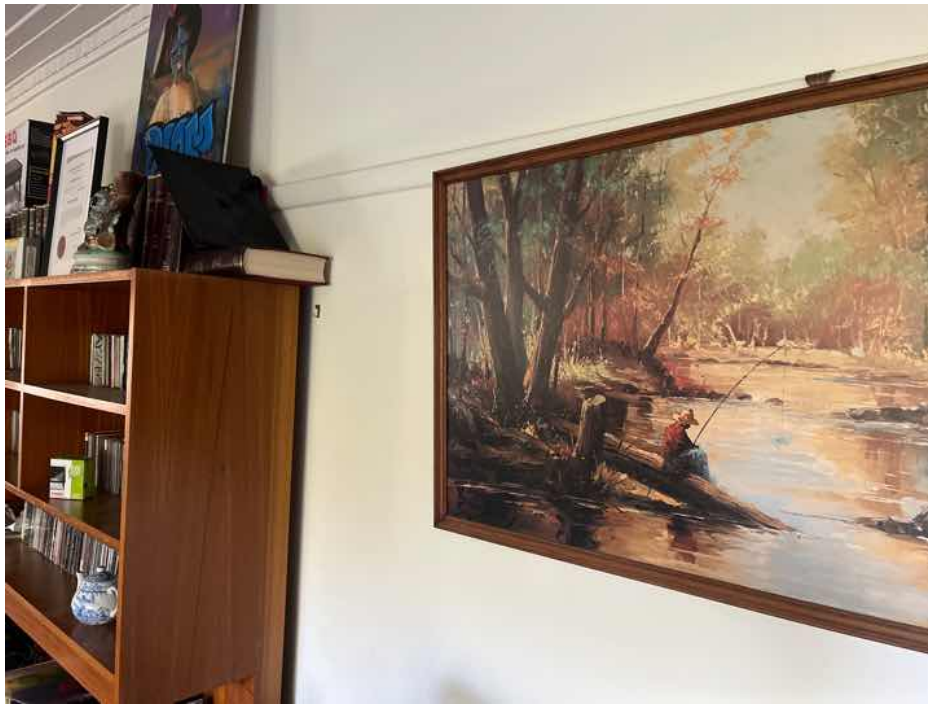
Settlement Cracks on wall areas. This can be related to differential settlement in footings, shrinkage in timber framing or poor plastering. Monitoring these cracks for 12 months is advised & if become wider or longer, you will need to contact a structural engineer to assess.

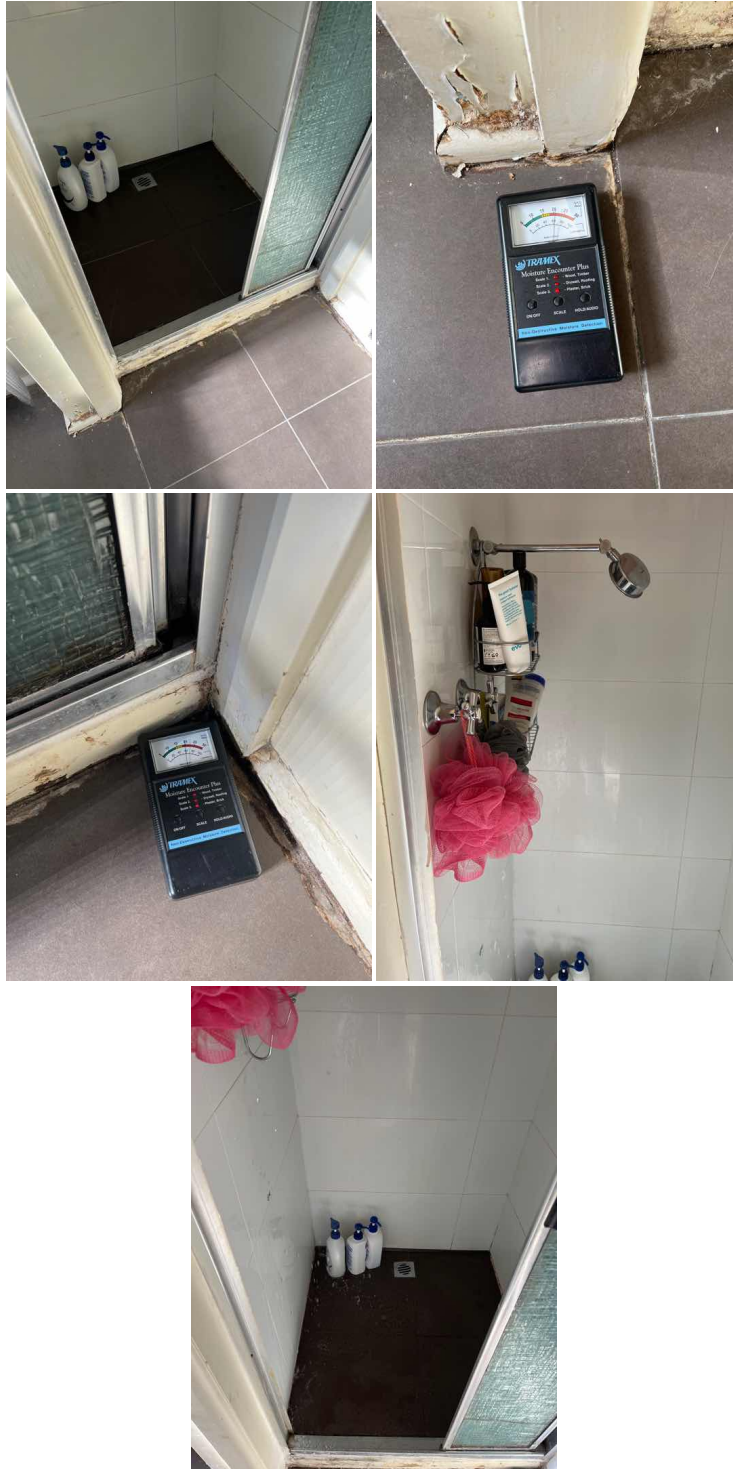
Old damage to flooring. This is possibly been caused by past leaks from the shower recess. Have a carpenter assess and repair as required

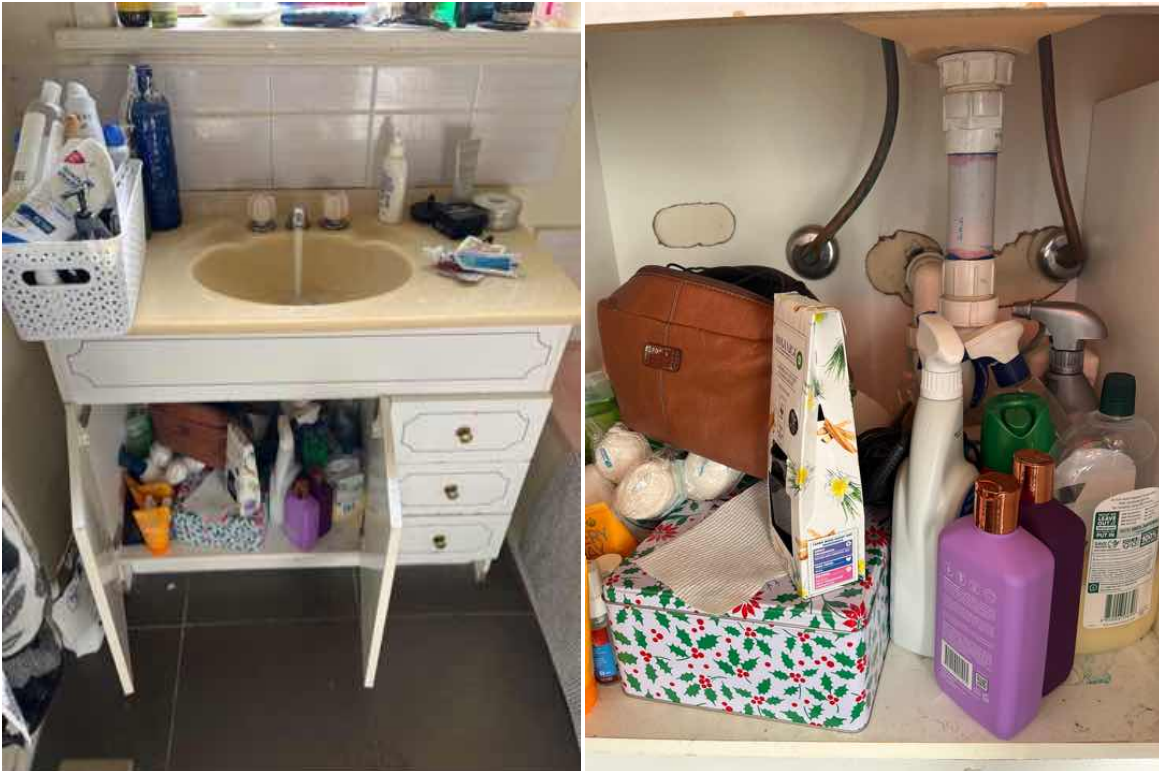
Tile grout has aged / deteriorated. Have sealed by qualified tiler.  
Blocked sink - have plumber remove trap and clean/assess.

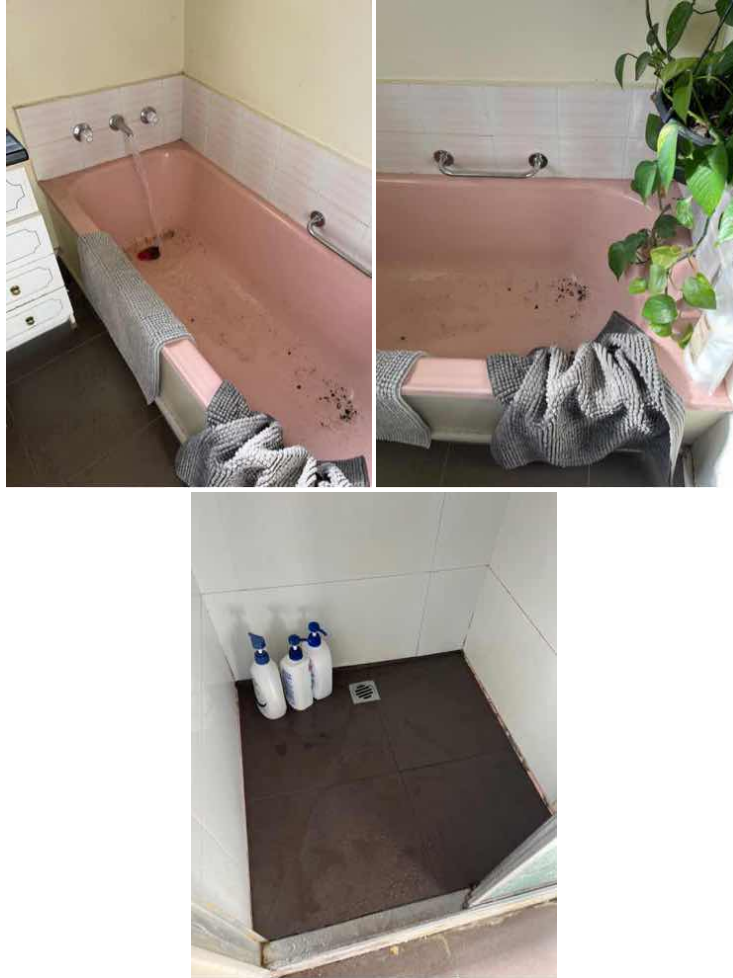
General age deterioration to bath base. Replace as required.

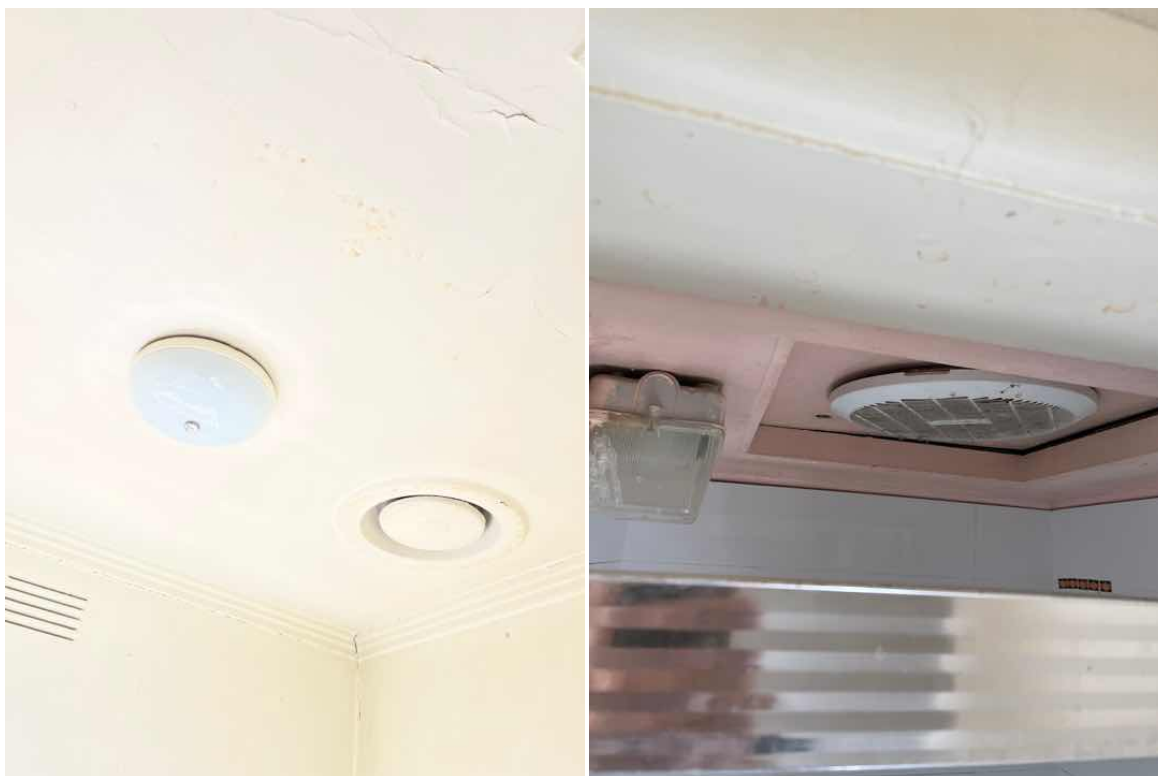
Noisy Exhaust Fan. Have assessed by an electrician. May require cleaning, replacement or securing. The exhaust fan is loosely fitted to the ceiling. Engage an electrician to rectify.

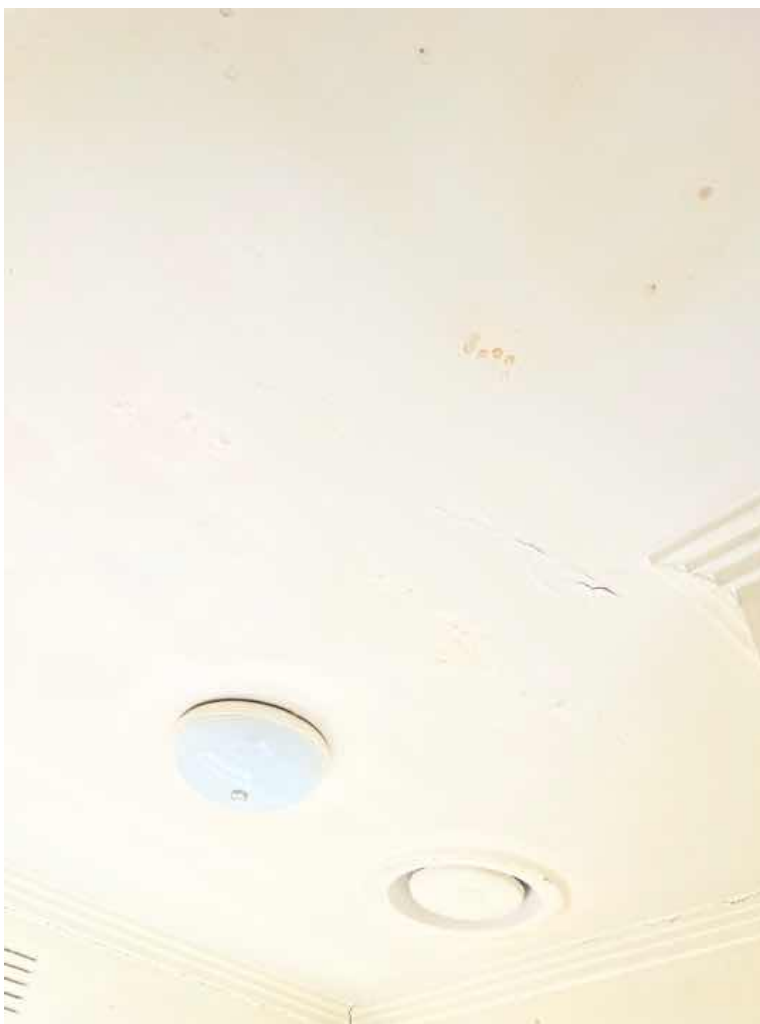
Mould evident in sections of the ceiling - we do not specifically report on mould type or hazards as per the Australian Standards AS 4349.1-2007 - we recommend you engage a mould specialist to assess & make recommendations as to cause and remedy.

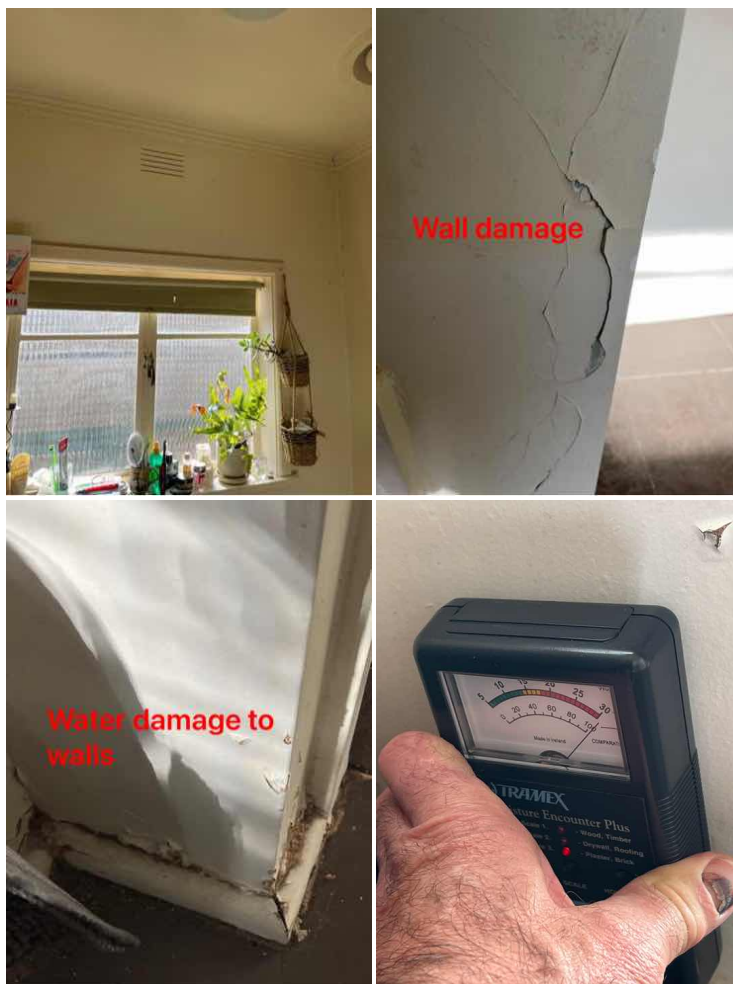
Mould evident in sections - we do not specifically report on mould type or hazards as per the Australian Standards AS 4349.1-2007 - we recommend you engage a mould specialist to assess & make recommendations as to cause and remedy.

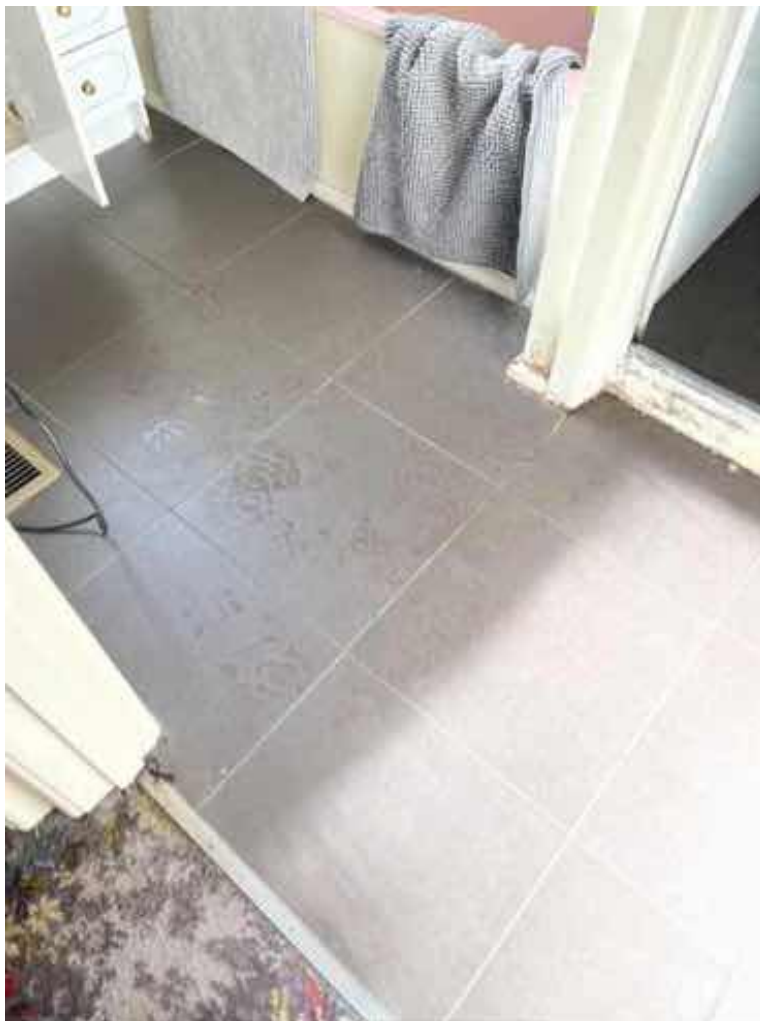
Excess moisture readings were obtained on the floor areas near the shower recess - This may be related to possible shower recess/tiles/base/pipe connection leaking. Engage a licensed plumber to ascertain if pipe leak related or shower recess water proofing is required. We cannot guarantee that timber wall/ floor framing members behind showers/wet areas are not damaged by water unless an invasive inspection is conducted which I strongly advise you have conducted.

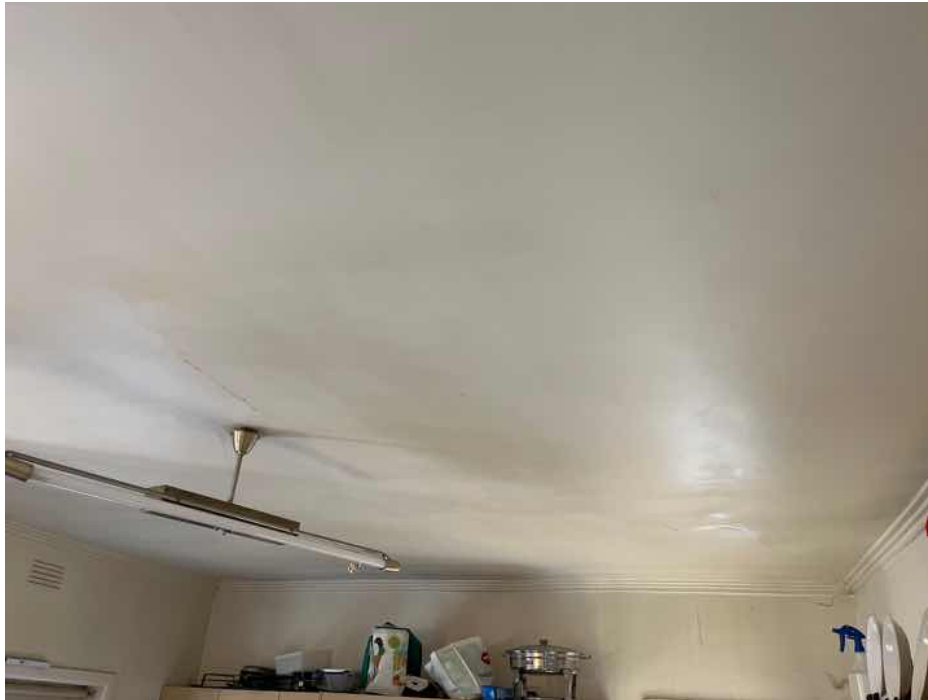
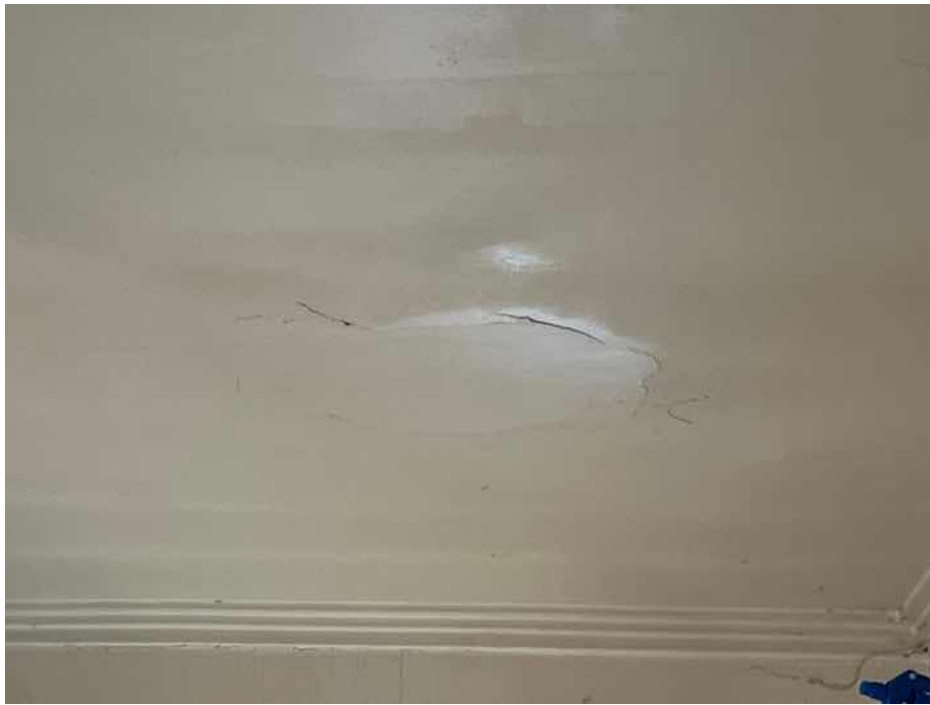
Ceiling stains - Appear to have emanated from Roof Area. No moisture readings obtained from same. These may have been repaired, however a qualified plasterer should be engaged for advice and recommendations and to assess damage to plaster and inaccessible framing.

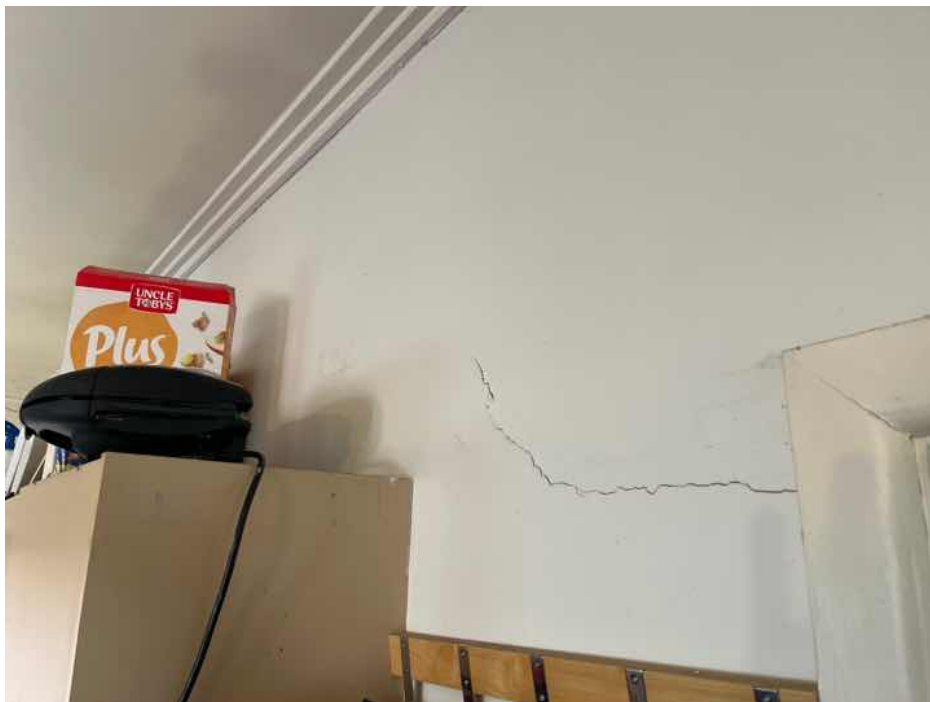
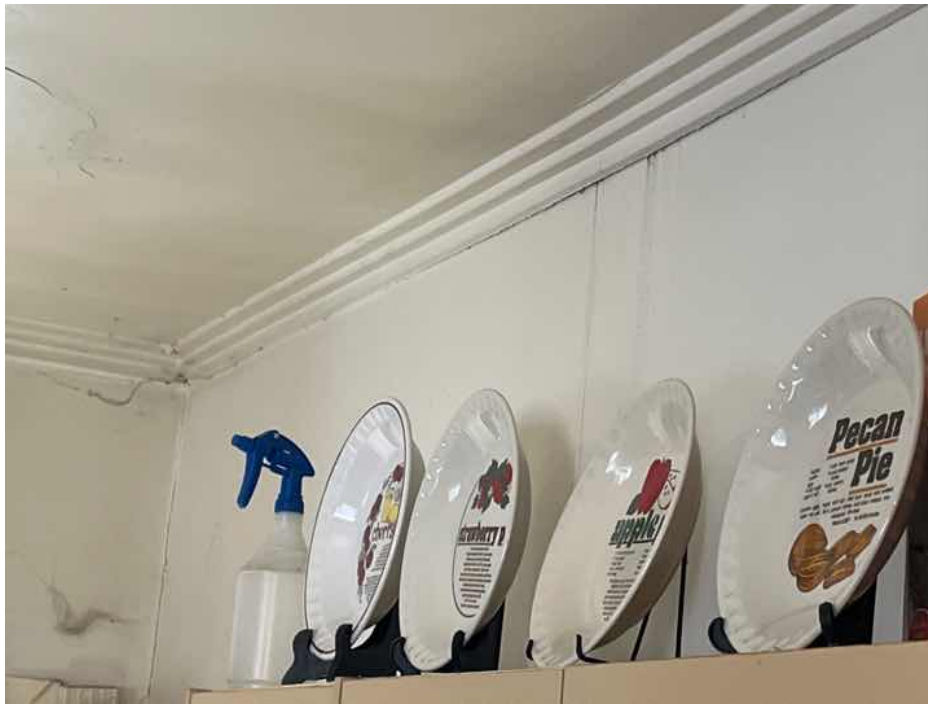
Wall stains - Appear to have emanated from Roof Area. No moisture readings obtained from same. These may have been repaired, however a qualified plasterer should be engaged for advice & recommendations and to assess damage to plaster & inaccessible framing.

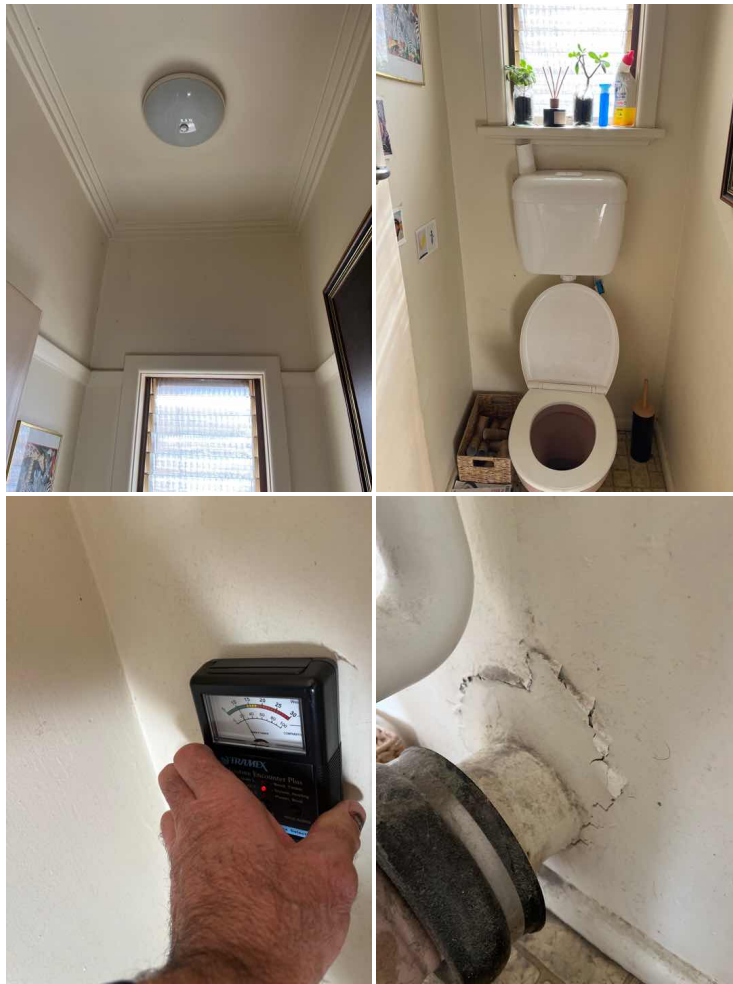
Settlement Cracks on wall areas. This can be related to differential settlement in footings, shrinkage in timber framing or poor plastering. Monitoring these cracks for 12 months is advised & if become wider or longer, you will need to contact a structural engineer to assess.

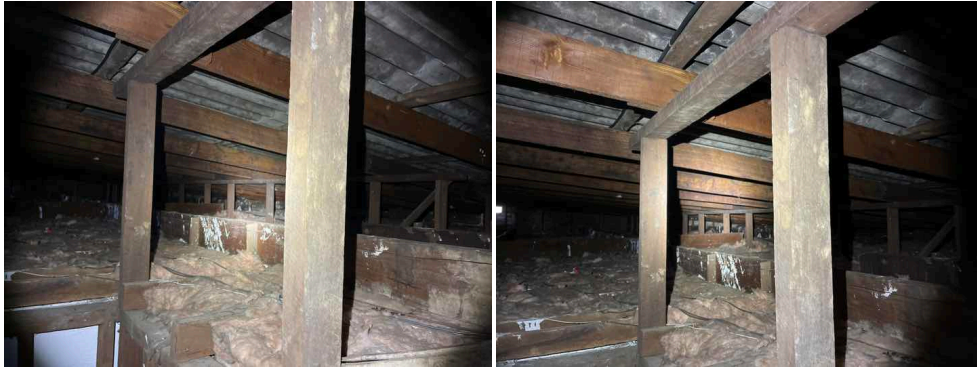
The strutting of the roofing is considered inadequate/poorly fixed - Engage a qualified Carpenter to assess.
