# Inspection Report - Non Invasive

**Safehome PTY LTD**

**1 Smith St, Pennydale, VIC, 3192**

Report/Agreement #	2305230921506
Inspection Date:	23 May 2023
Inspection Time:	11:00 am

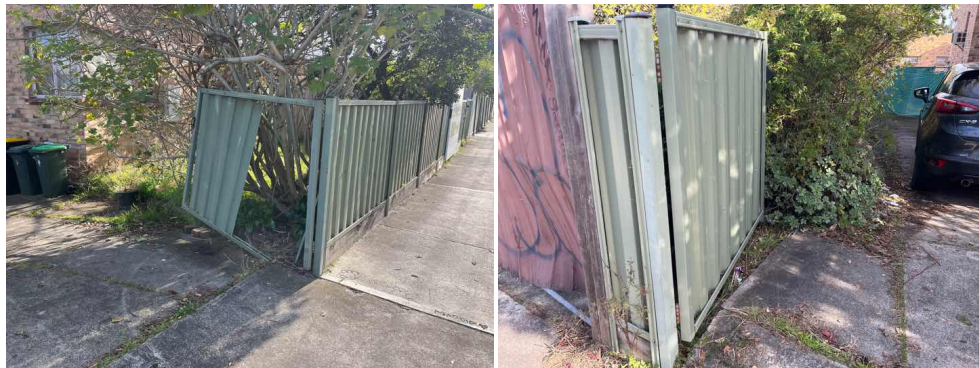
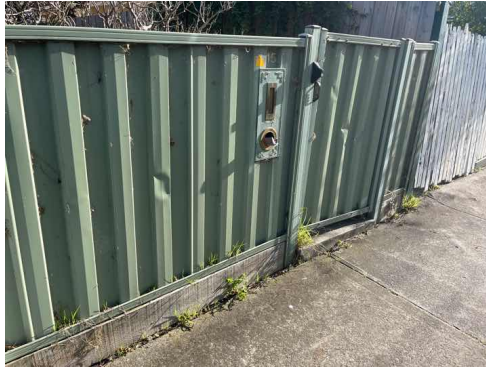
Gate has detached. Have rectified by trades person.

The inspector did not brake fence timber open or dig grounds around the base of the posts. Any leaning or unevenness is typically indicative of fence post rot subsurface and repairs by a fencing contractor must be carried out as soon as possible due to safety concerns.

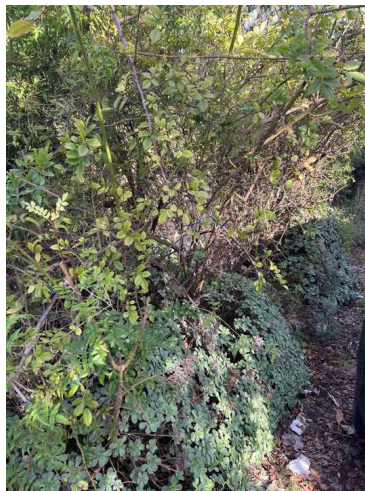
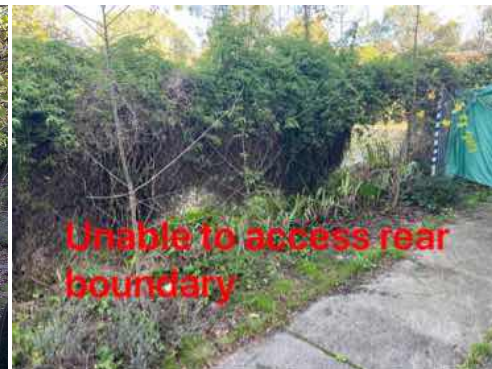
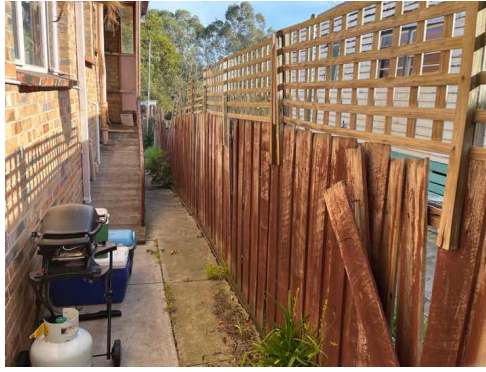
Fence rails detached due to rot or deterioration. Repair as soon as possible. Not safe to climb on and possible collapse. Safety Hazard.

Plants are covering some fence areas & Not able to thoroughly inspect for defects.

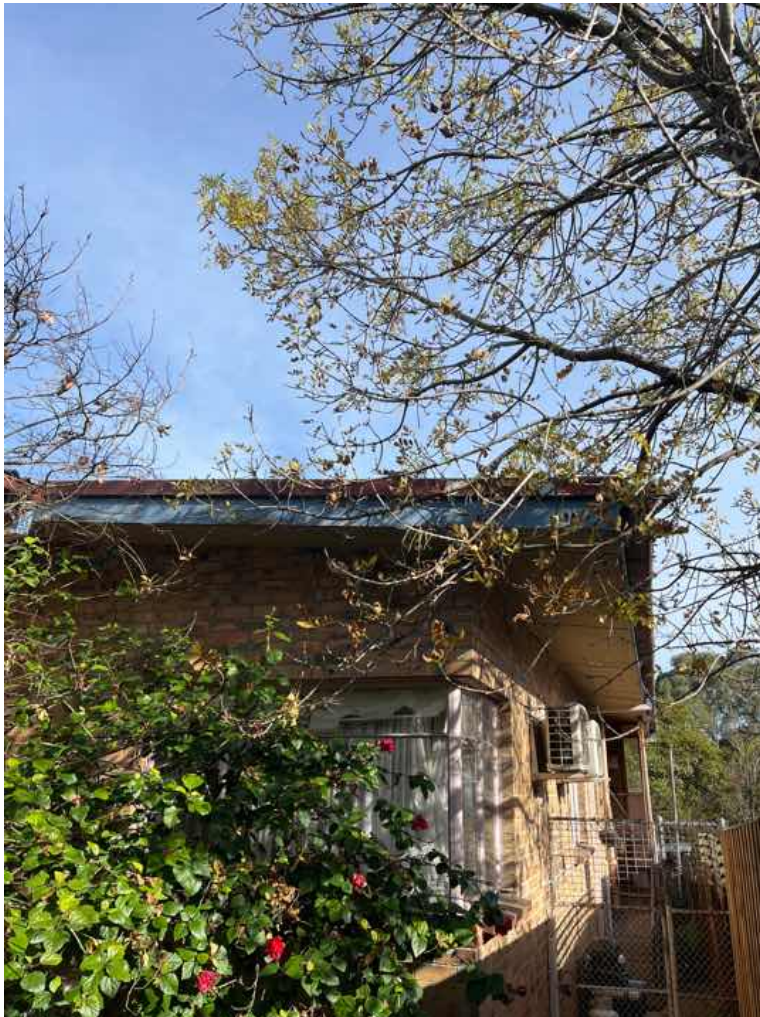
Trees are overhanging the roof in areas. This will cause gutter and down pipe blocks and I recommend you cut them back away from the roof.

Where trees are too close to the house this could affect the performance of the footing as the moisture levels change in the ground. A geo-technical inspection can determine the foundation material & provide advice on the best course of action with regards to the trees. Please download & read the CSIRO's maintenance guide relating to trees.

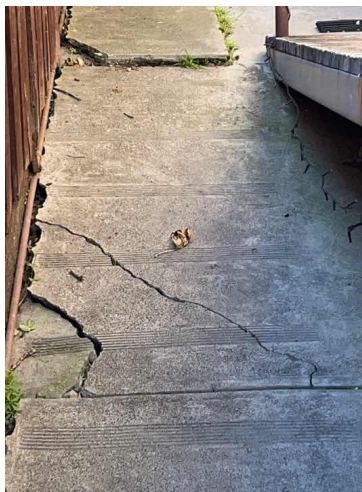
SITE	PATHS	Path Condition	The driveway is being adversely affected by tree roots. This should be rectified & repairs carried out.

The driveway is in poor condition & replacement by concreter recommended.

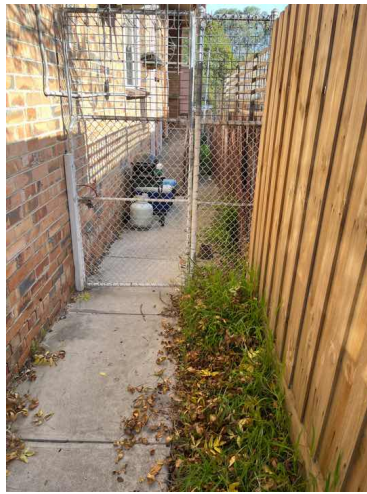
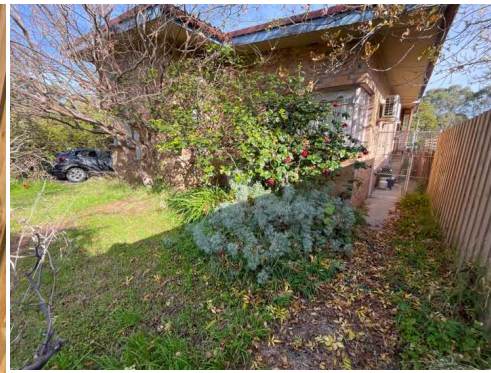
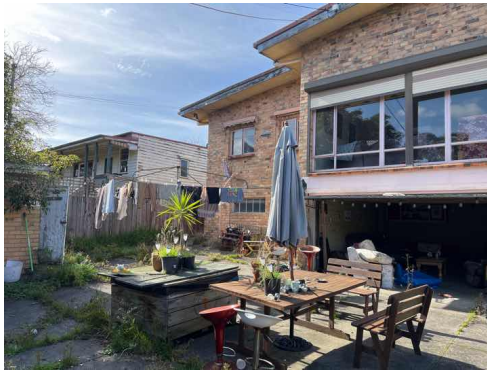
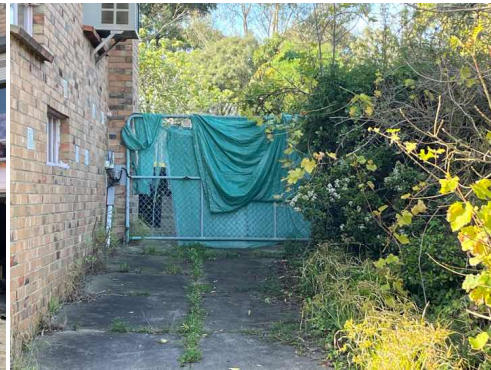
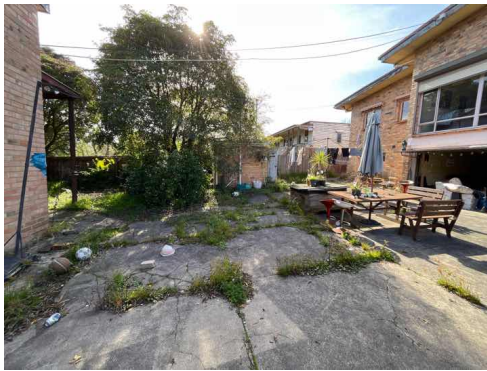
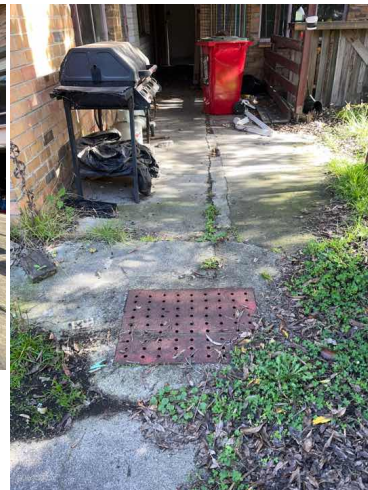
Excessive growth - unable to assess. Cut back and re-assess.

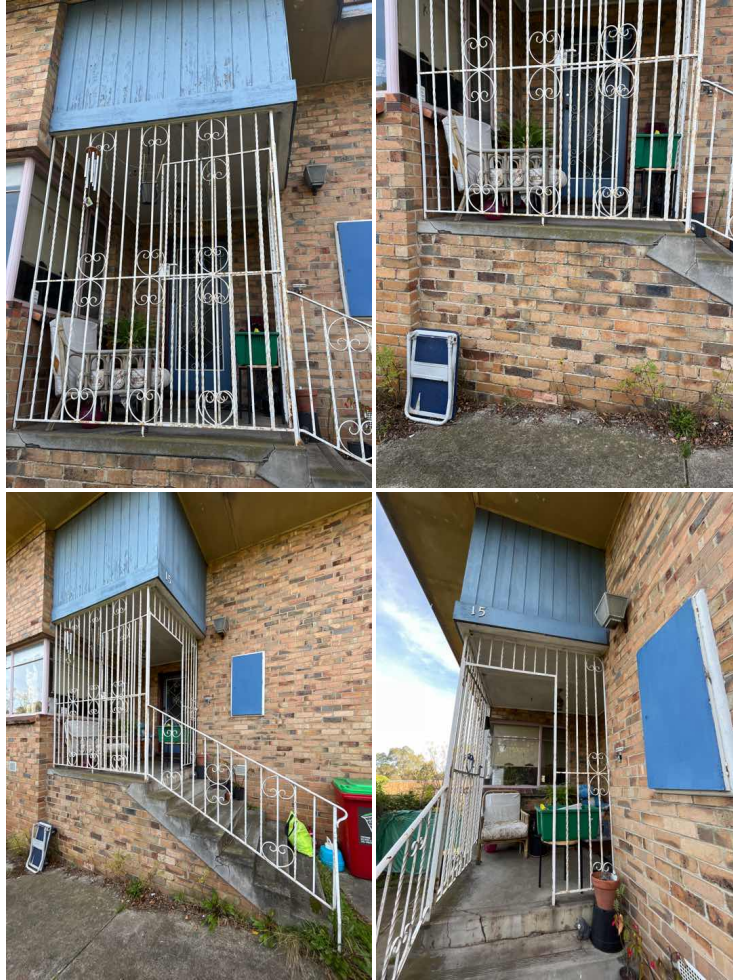
On inspection, defects were noted that may require further assessment & recommendations by licensed tradesperson.

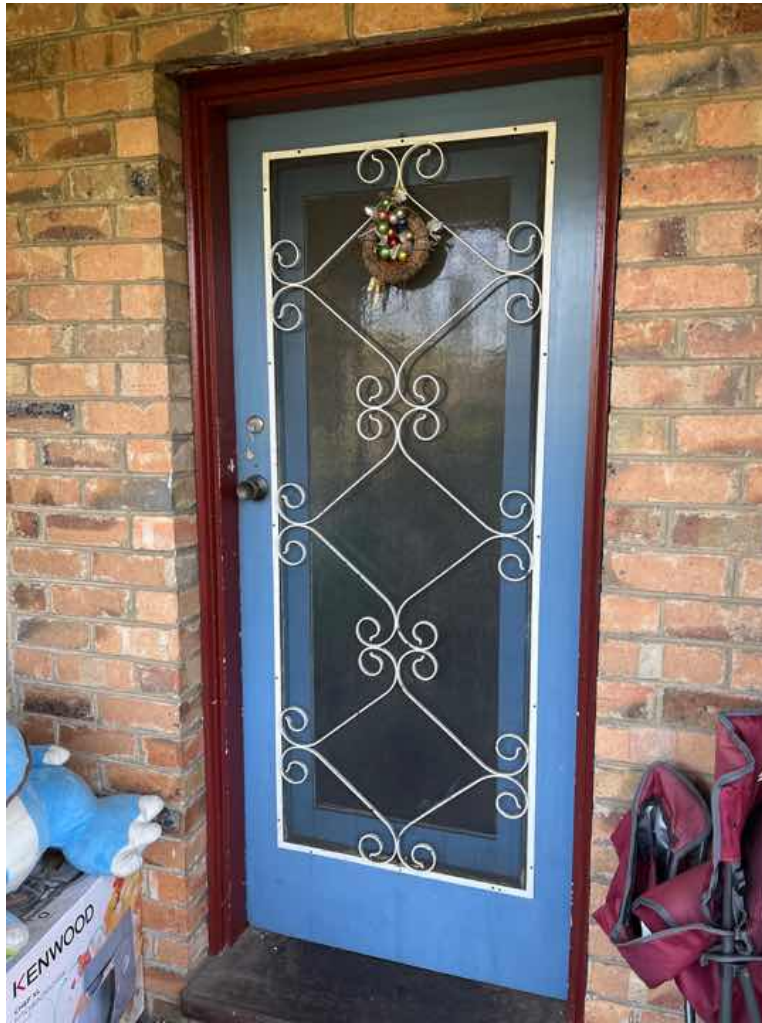
General age and/or wear and/or deterioration to door/components - General maintenance works required.

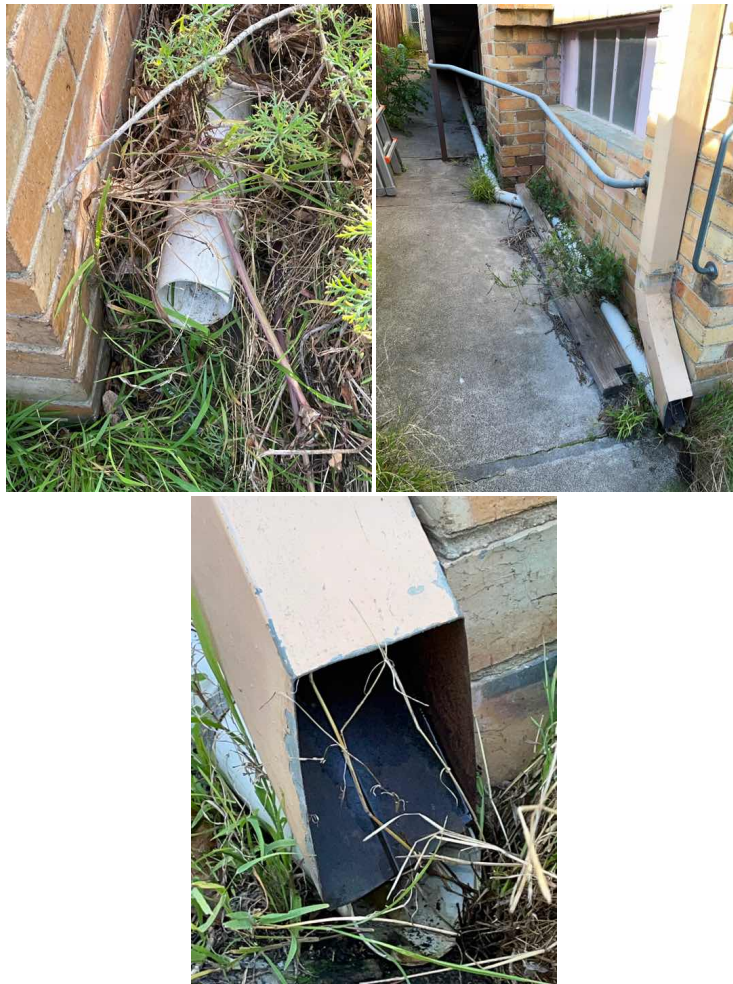
Rust penetrations in down pipe. Over time, this has potential to cause differential settlement to the footings and rising damp in Masonry dwellings. A qualified plumber should be engaged to replace.

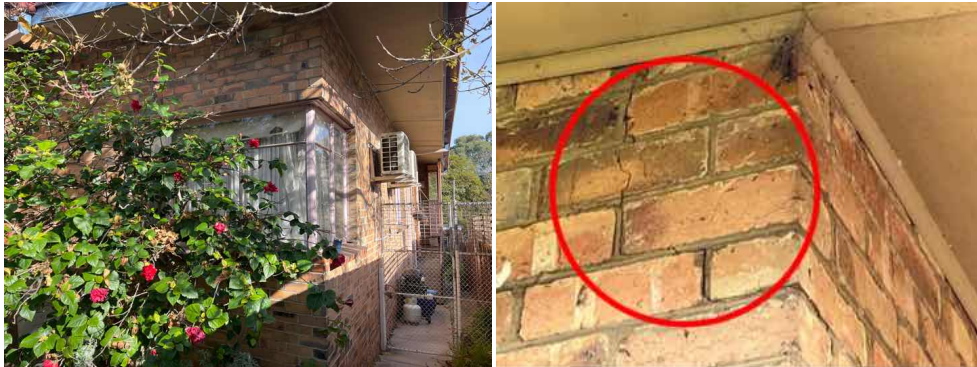
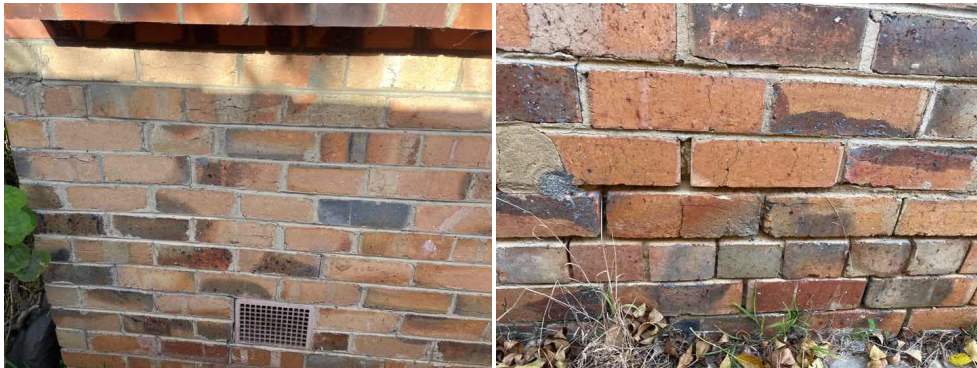
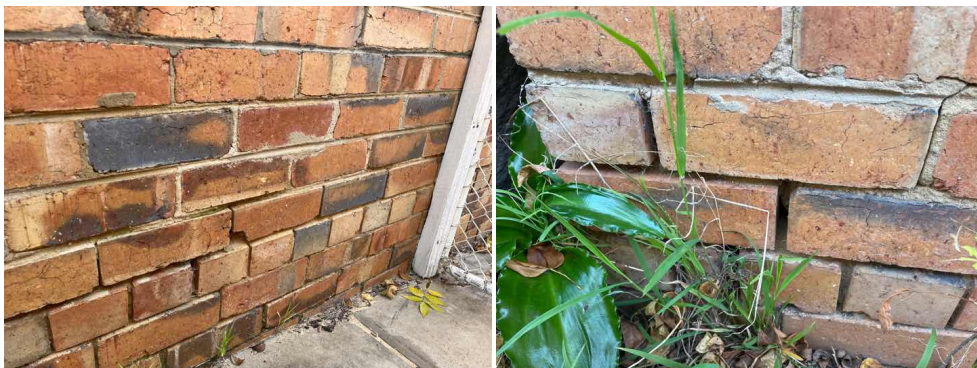
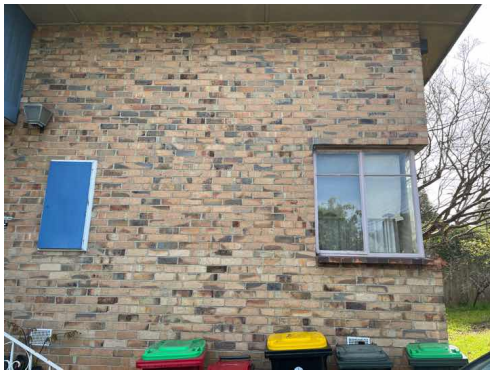
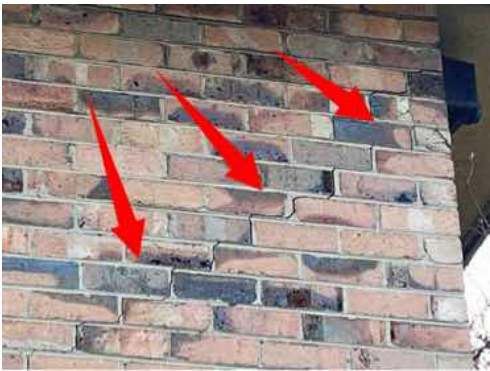
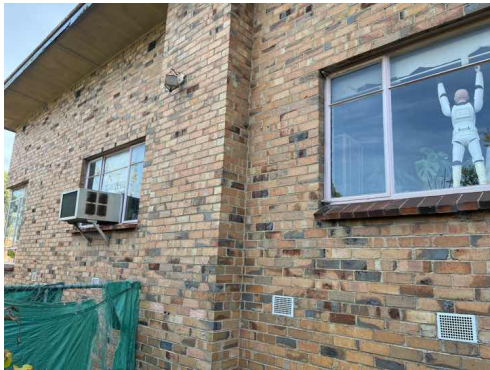
Brick fretting on wall section/s. This can be associated with damp/drainage issues. Further investigation required by a qualified damp proofing & drainage specialist for advice & recommendations.

Damaged brick/s sections. Engage brick layer to assess / replace.

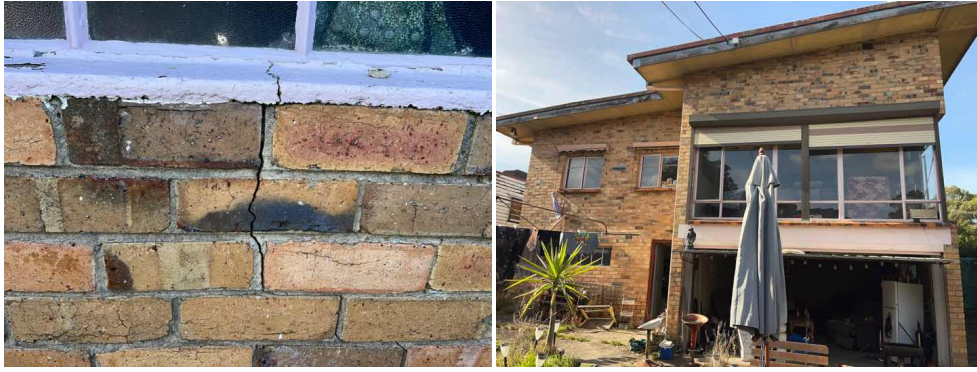
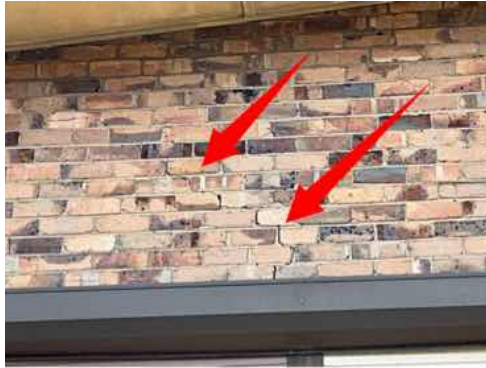
### **Mortar Condition**

General ageing & deterioration to brick mortar sections - This is common in older dwellings we inspect & can be associated with surface water ponding alongside walls, excessive watering over time - Engage a qualified brick layer for advice & recommendations regarding repair.

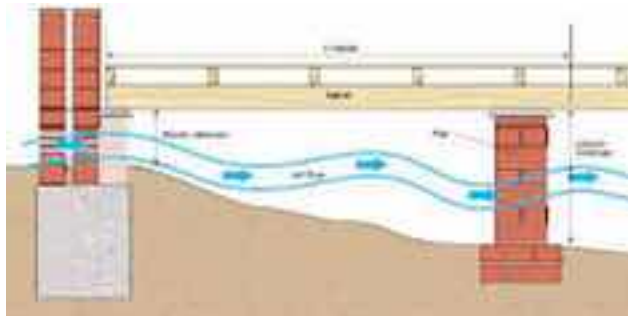
Salt Residue visible on lower external wall areas. This is normally associated with Rising Damp/poor drainage/ water ponding alongside walls - Engage a qualified damp proofing specialist for advice & recommendations as soon as possible.

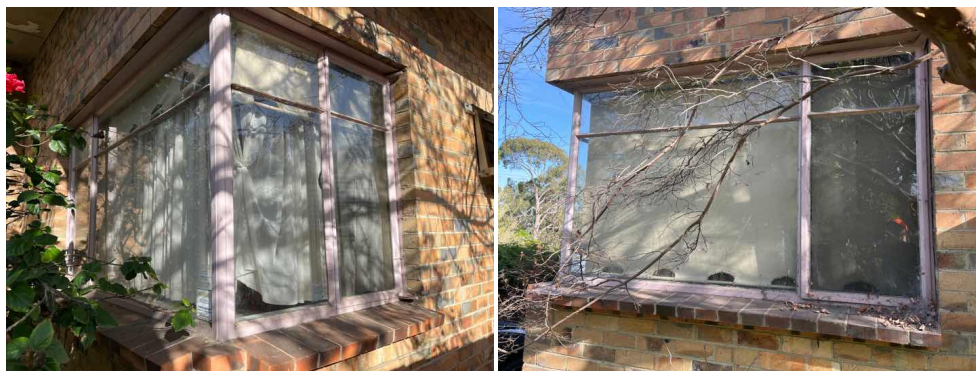
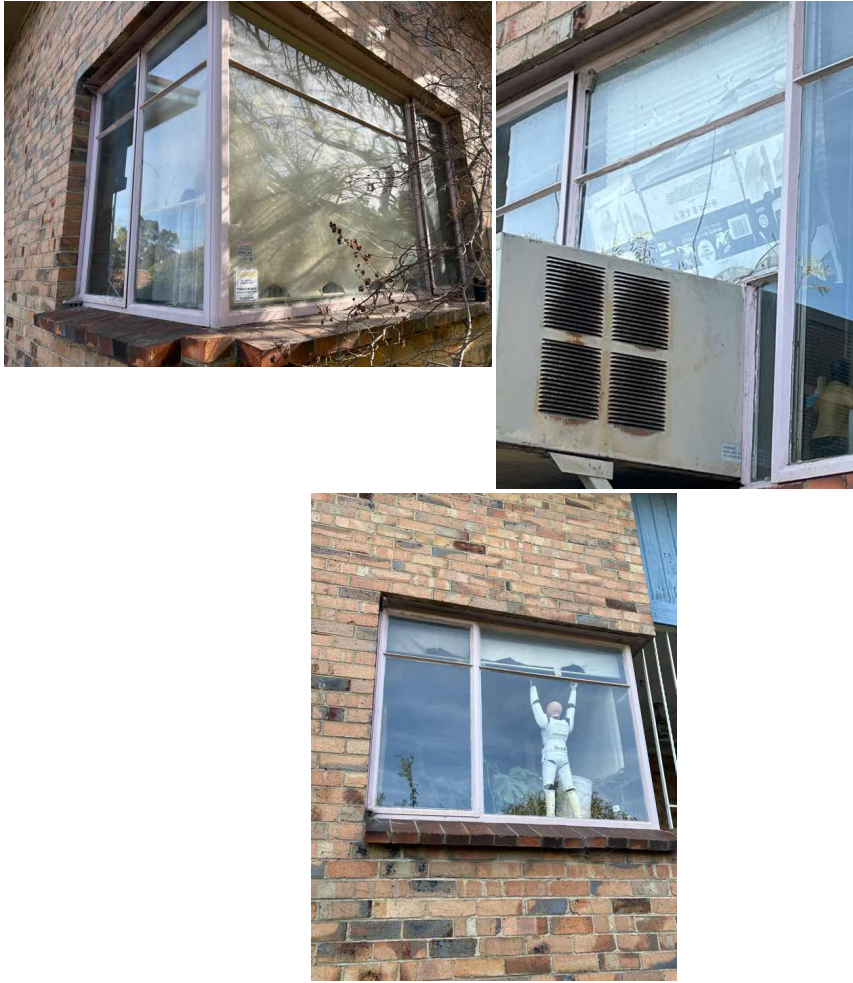
General ageing / deterioration in areas of windows/components. General upkeep or maintenance advised.

Sections of the external windows have paint deterioration - Engage a qualified painter for repairs.

Deterioration of sections of window putty was observed - A qualified glazier should be engaged for minor repairs.

Window pane cracked. Engage a qualified glazier to repair/replace as soon as possible. Cracked windows can be a safety hazard.

Lintel rust in sections. This may cause cracking in wall linings above the window - A qualified brick layer should be engaged for repairs & recommendations regarding restricting rust or replacement.

Rust is evident in sections of the homes window framework. Some areas should be repaired. A qualified carpenter should be engaged for advice & recommendations regarding restriction of rust.

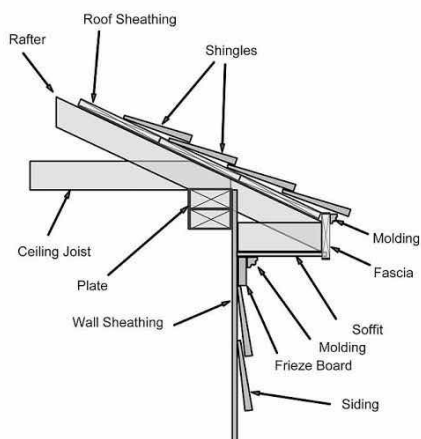
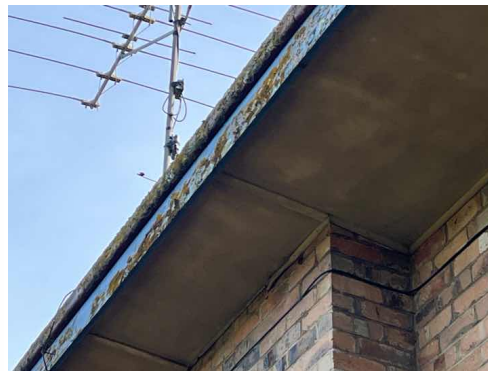
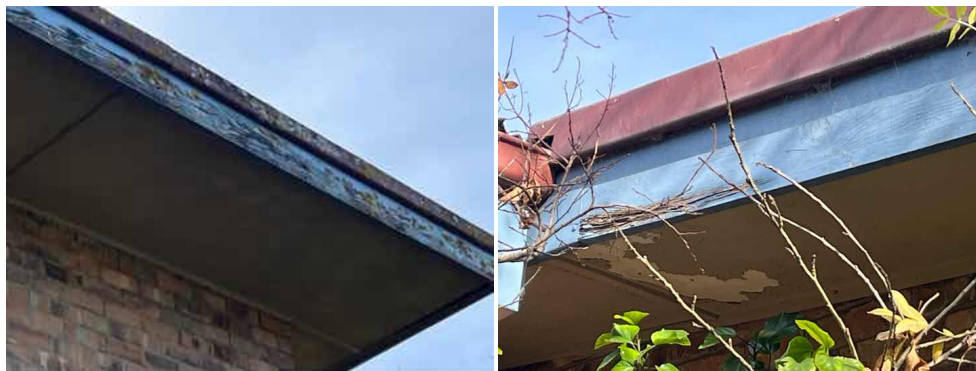
Fascia

Minor deterioration & ageing evident to timber fascia. Maintenance works, general upkeep should be carried out. Timber fungal decay (rot) visible. A qualified carpenter should be engaged to repair/seal all affected timbers.

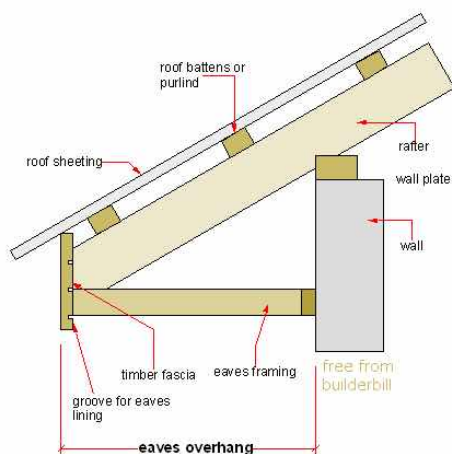
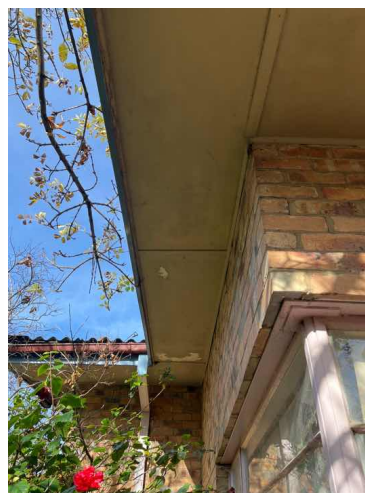
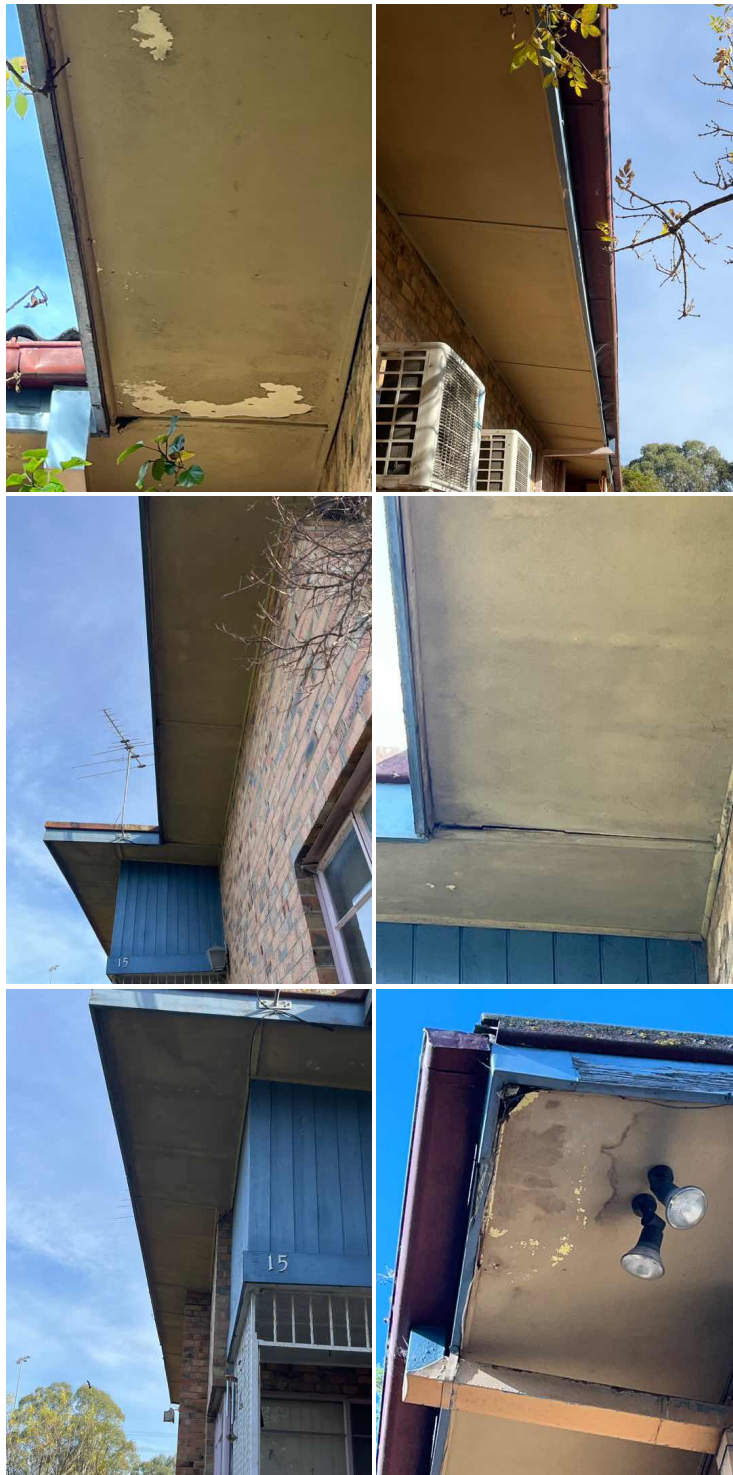
Minor eave deterioration & ageing evident - Maintenance works, general upkeep should be carried out. Fibrous Cement Sheeting sections. We recommend an ASBESTOS Inspection be conducted by a licensed Asbestos Inspector prior to a decision to purchase.

Timber fungal decay visible in sections - A qualified carpenter should be engaged to assess/repair.

Sections of the Eaves have paint deterioration - Engage a qualified painter to paint/seal.

Quad deteriorated or detached in areas - Contact a Licensed carpenter for minor repair or replacement.

Eave lining stains detected in sections. Appears current leak related. Engage a licensed plumber for to assess/repair as required.

Eaves damaged in sections. Replace at leisure.

Eave detached in areas. Have carpenter repair.

Staining under pipe penetration. Likely a flashing leak. Have plumber assess and repair as required.

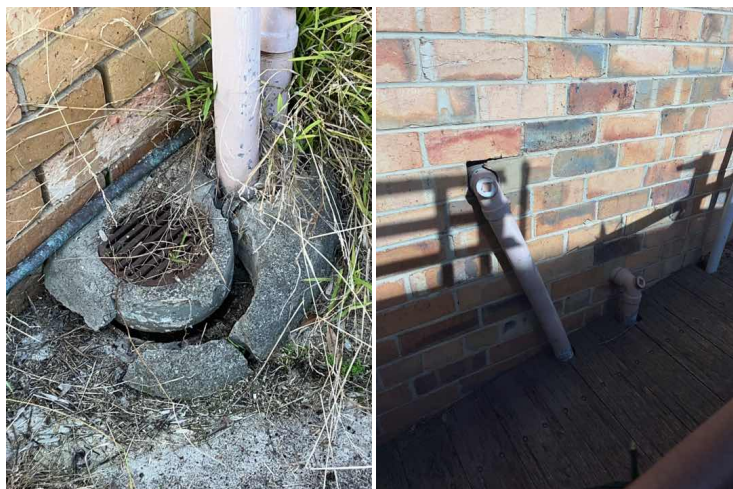
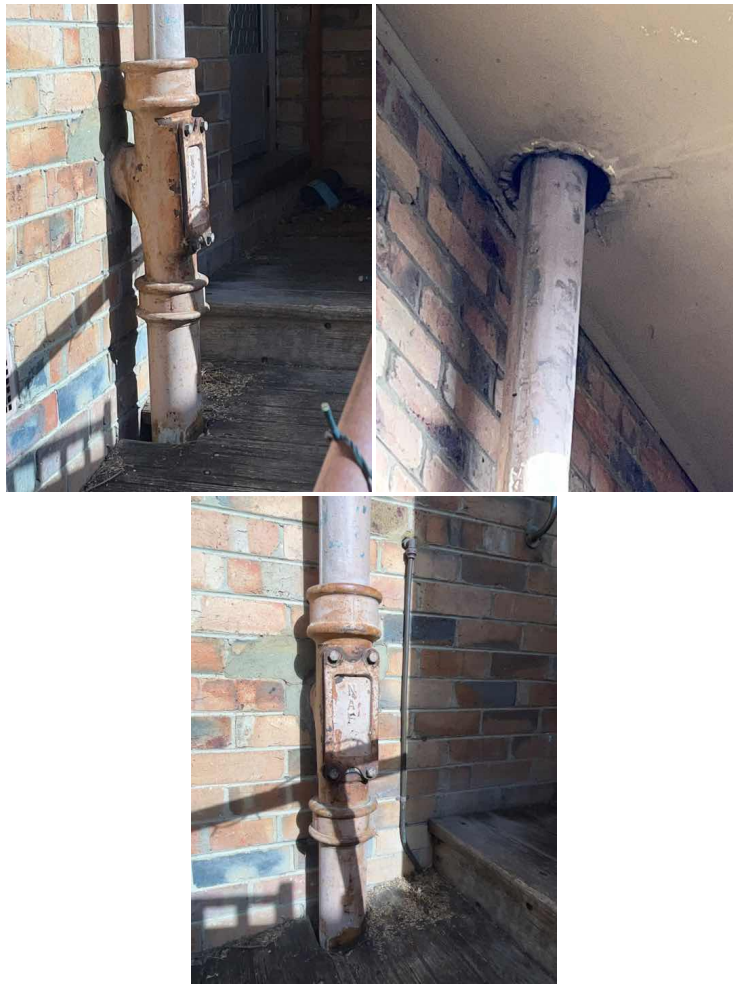
Opening/gaps between plumbing & wall penetration - Plumbing holes are defective if they are not properly grouted. Engage a brick layer or plumber to rectify.

Settlement/cracking visible in sections of the plumbing concrete base connection - Engage a qualified plumber for advice & recommendations.

The plumbing is poorly sealed to the base drain in areas - Engage a qualified plumber to seal to avoid blocking.

Rusted pipe work - Have plumber assess & repair as required.

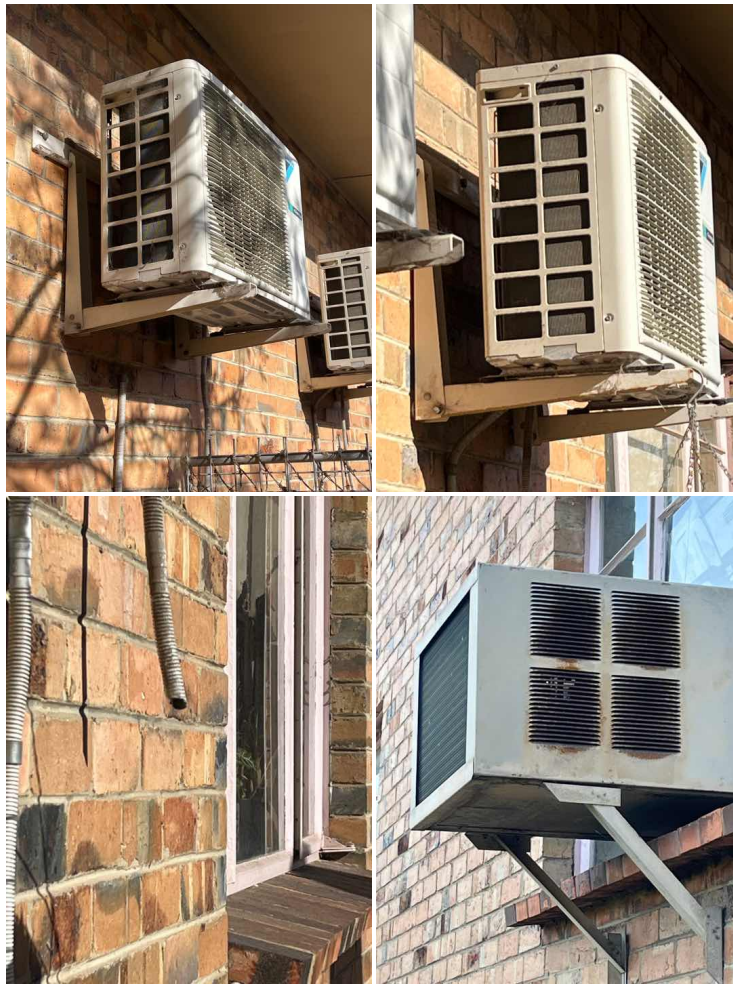
The split system overflow requires diverting to a drain or further from the dwellings wall or footings. Excess water ponding alongside walls & into perimeter footings has the potential to cause rising damp, differential settlement & wall cracks over time. It is also conducive to termite infestation. Engage a plumber to rectify.

Rust deterioration evident on heating or cooling unit sections - Engage a qualified plumber for advice & recommendations.

General Age and/or Damage to unit/s. Engage a heating/cooling contractor to assess & test.

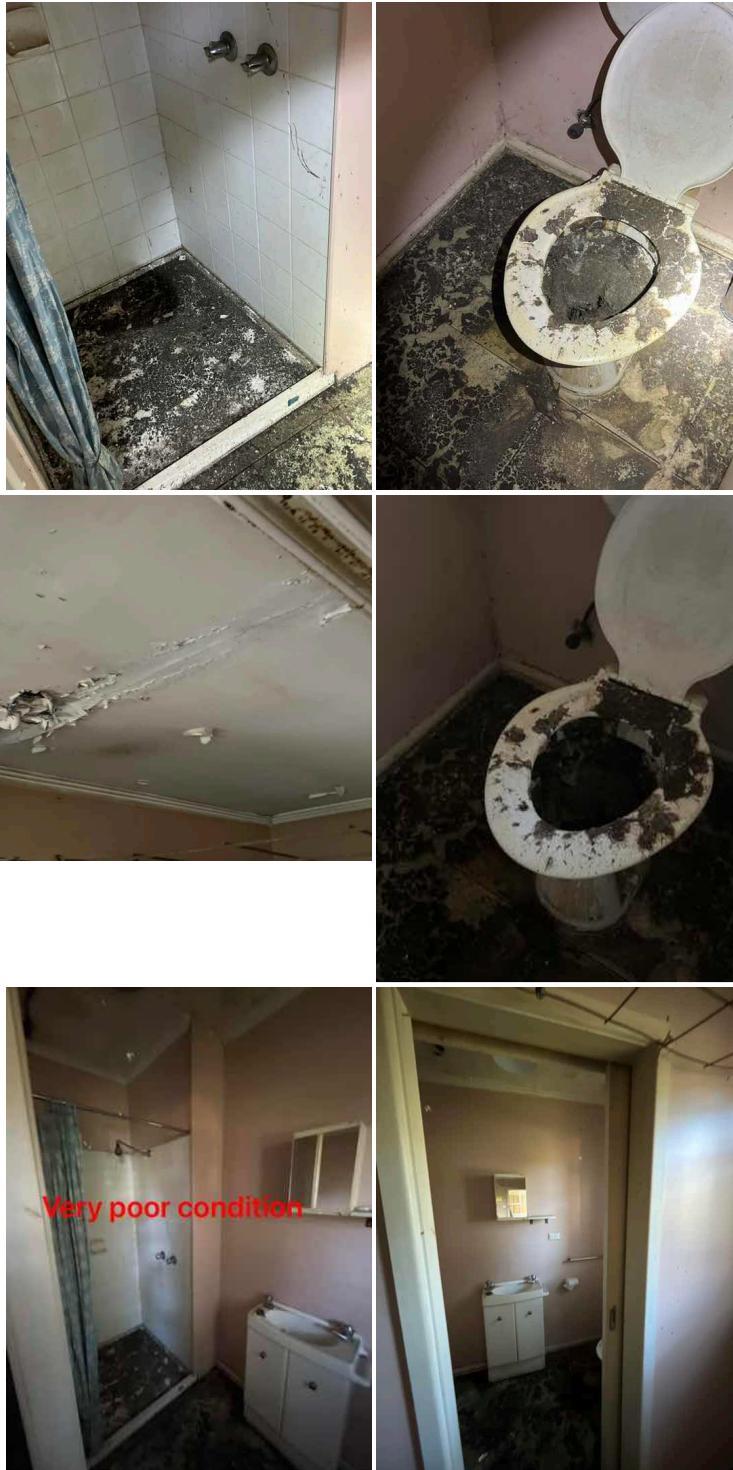
The door has been removed.

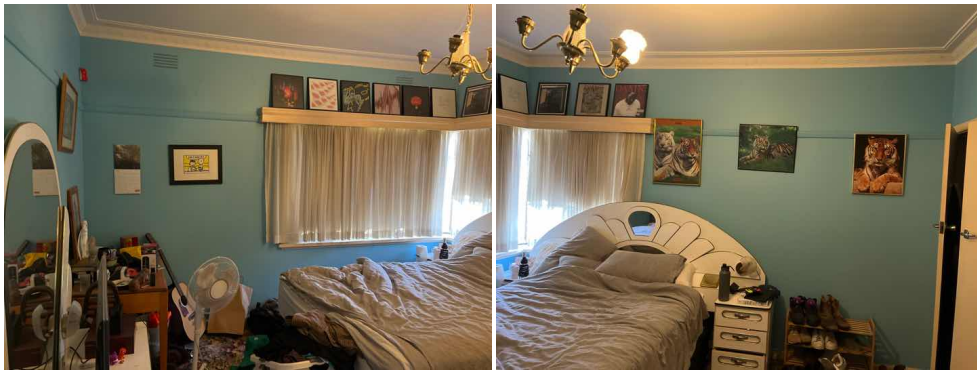
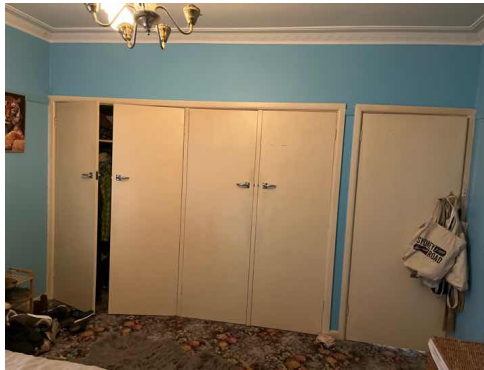
General age and/or wear and/or deterioration to door/components - General maintenance works required.

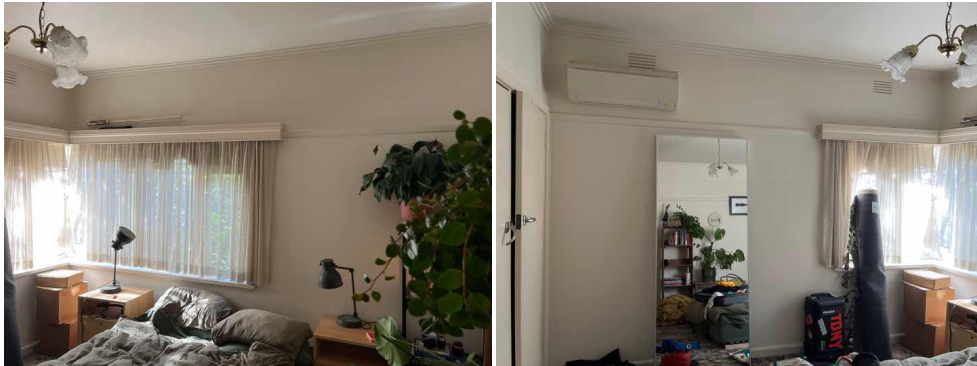
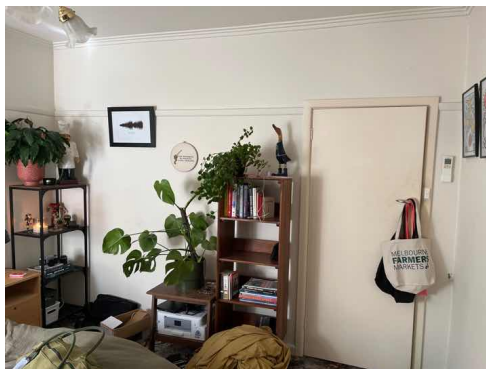
General age and/or wear and/or deterioration to door/components - General maintenance works required.

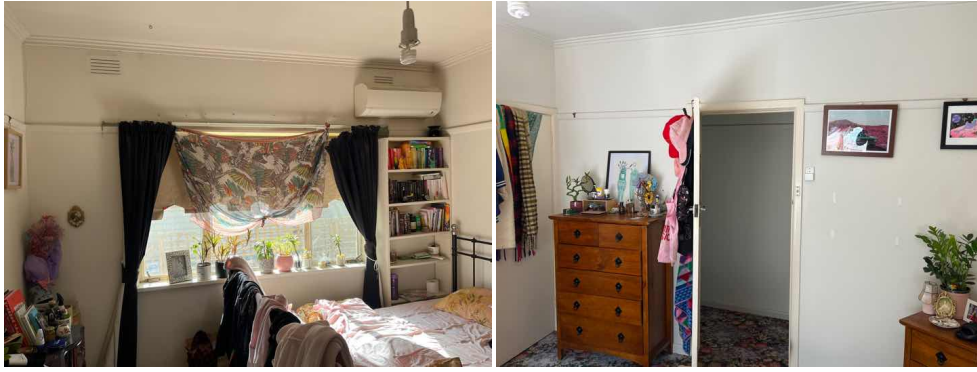
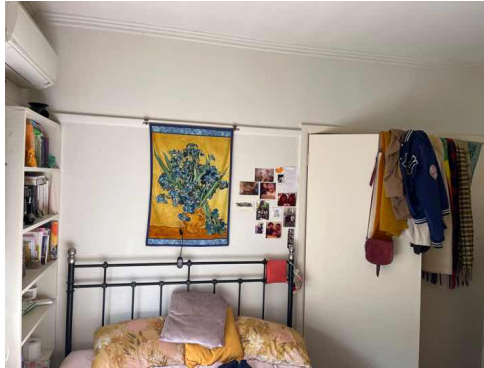
General age and/or wear and/or deterioration to door/components - General maintenance works required.

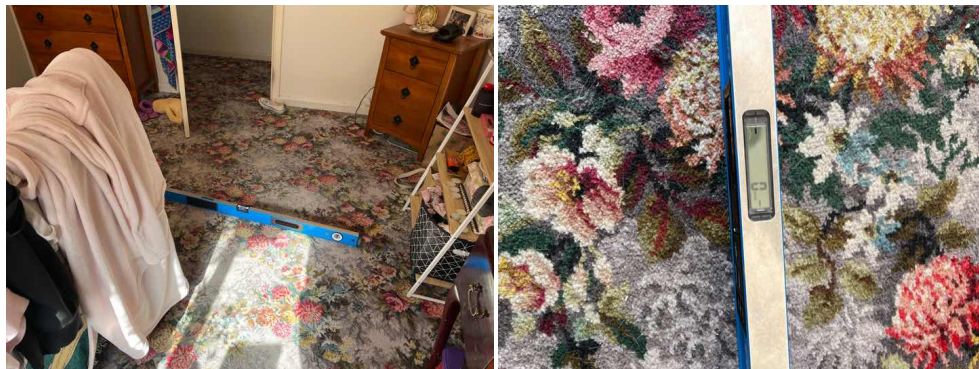
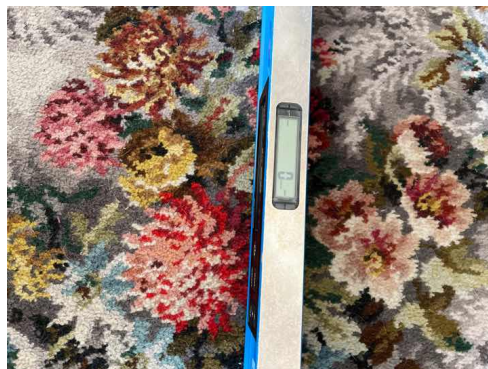
Unevenness visible in sections of flooring - Possible causes - older homes have been re-stumped & not leveled adequately or could be some recent or past differential settlement in the footings. A qualified carpenter or stumping contractor should be engaged to assess immediately - homes levels & adjustments may be necessary.

Minor creaking in flooring sections - In some circumstances this can be due to workmanship, fixings loosened/deteriorated, dampness/rain during construction. A qualified carpenter should be engaged to ascertain cause & remedy.

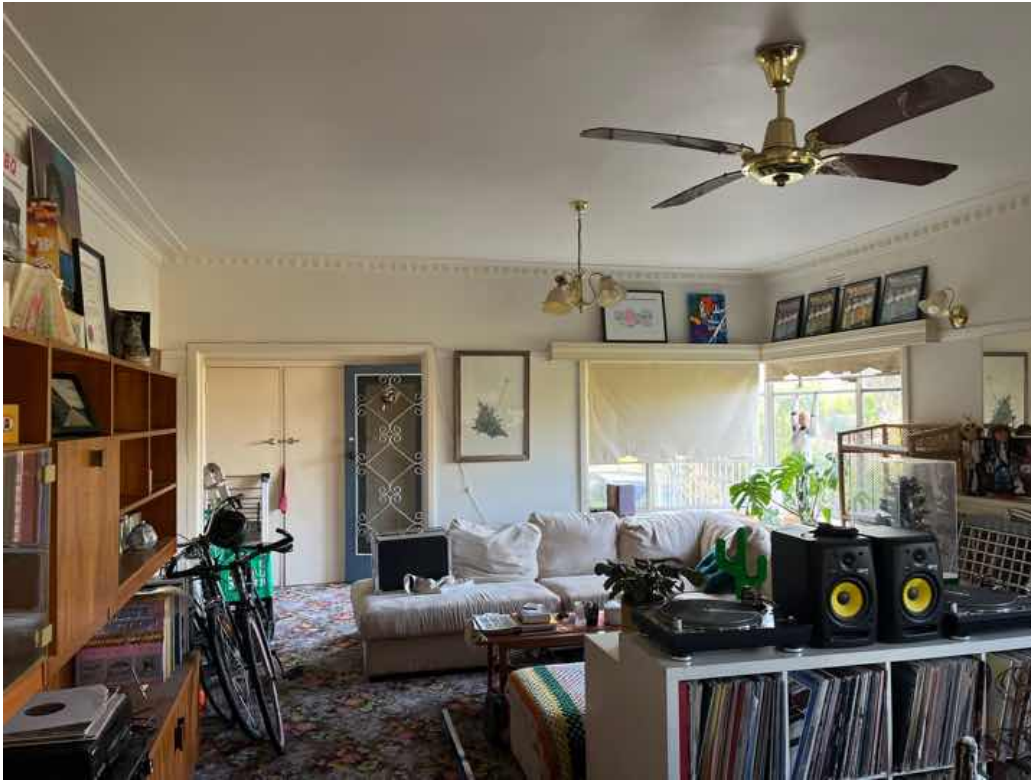
Serviceable condition with no notable structural defects sighted.

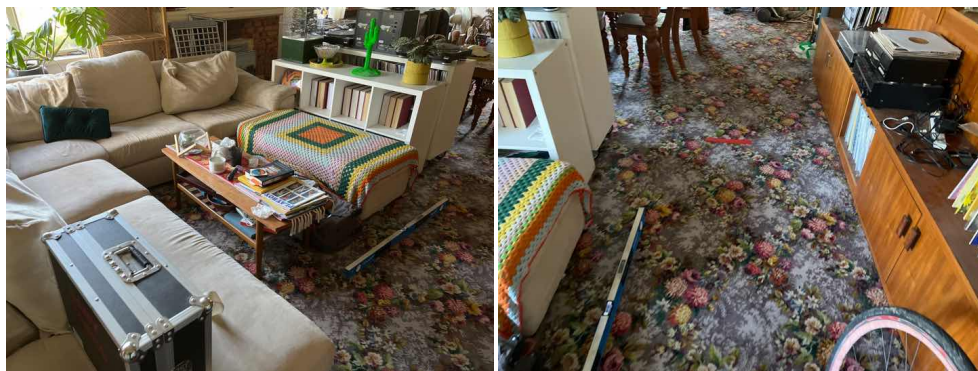
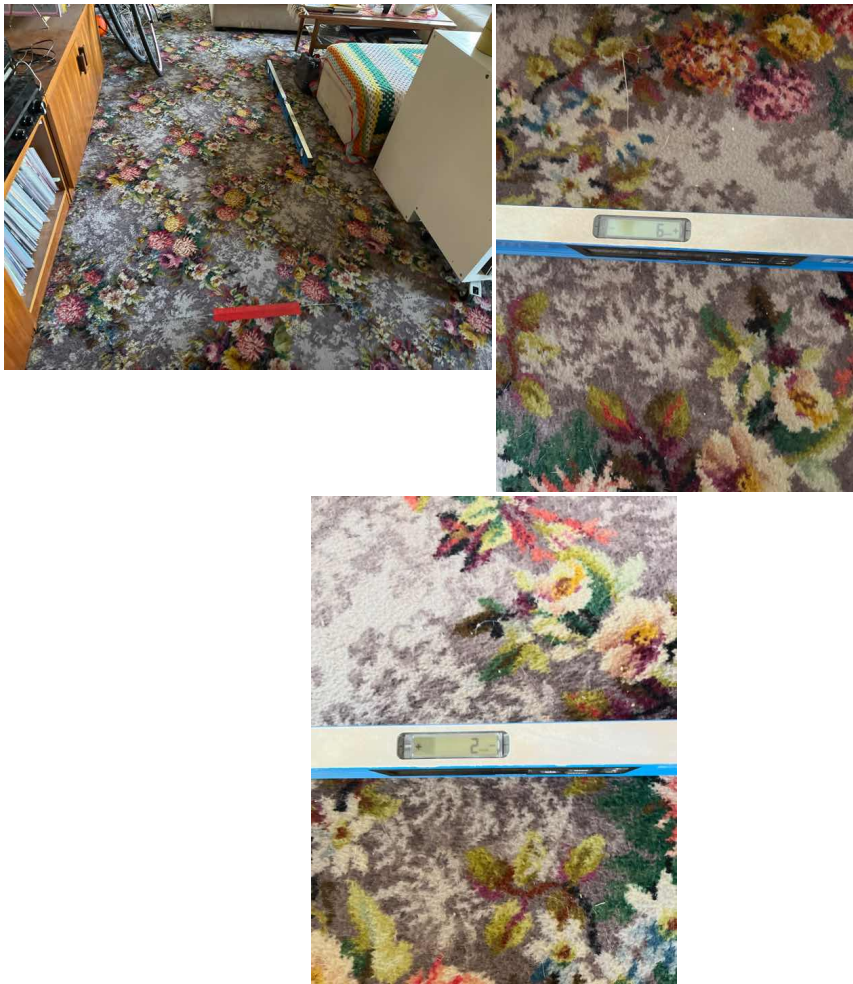
General age, deterioration or wear and tear to sections of the floor linings. General repair and maintenance advised.

Minor creaking in flooring sections - In some circumstances this can be due to workmanship, fixings loosened/deteriorated, dampness/rain during construction. A qualified carpenter should be engaged to ascertain cause & remedy.

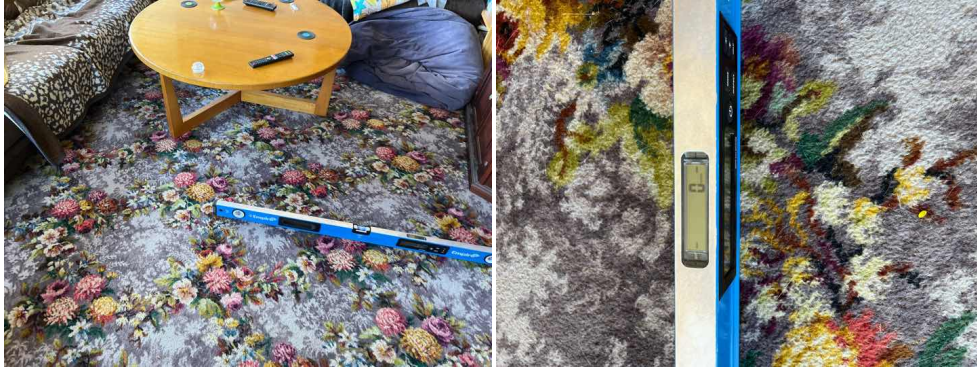
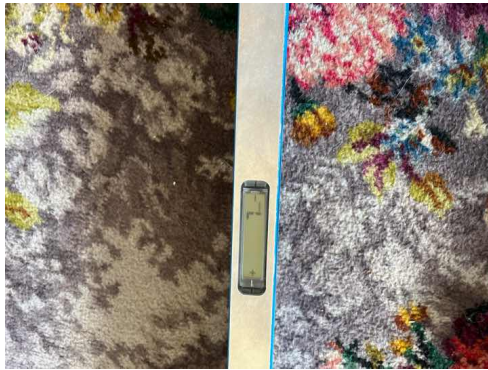
General age, deterioration or wear and tear to sections of the floor linings. General repair and maintenance advised.

Minor creaking in flooring sections - In some circumstances this can be due to workmanship, fixings loosened/deteriorated, dampness/rain during construction. A qualified carpenter should be engaged to ascertain cause & remedy.

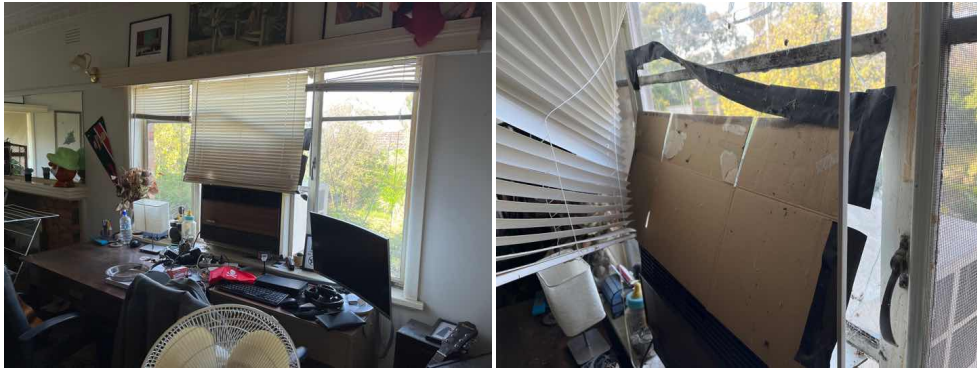
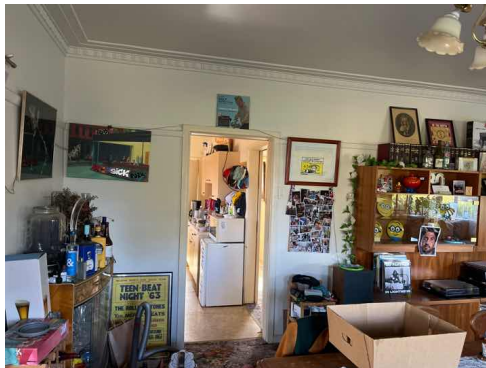
General age/wear, paint deterioration or patching to window areas. General maintenance works required by carpenter and/or painter.

Cracked glass pane - A glazier should be engaged as soon as possible to replace as this is a potential safety hazard.

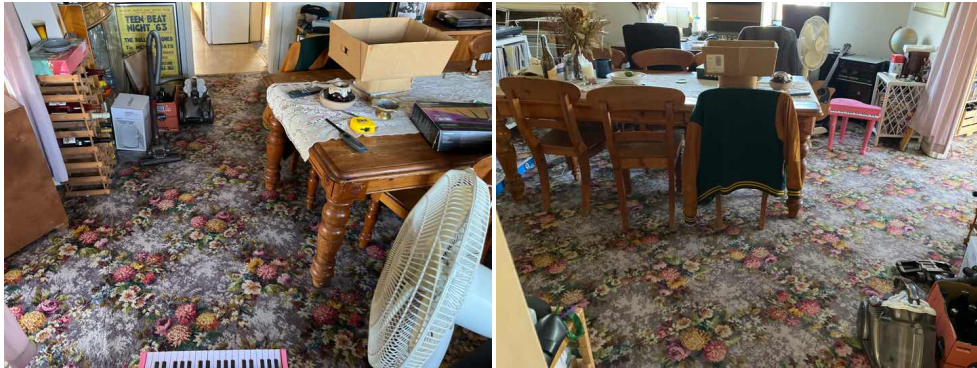
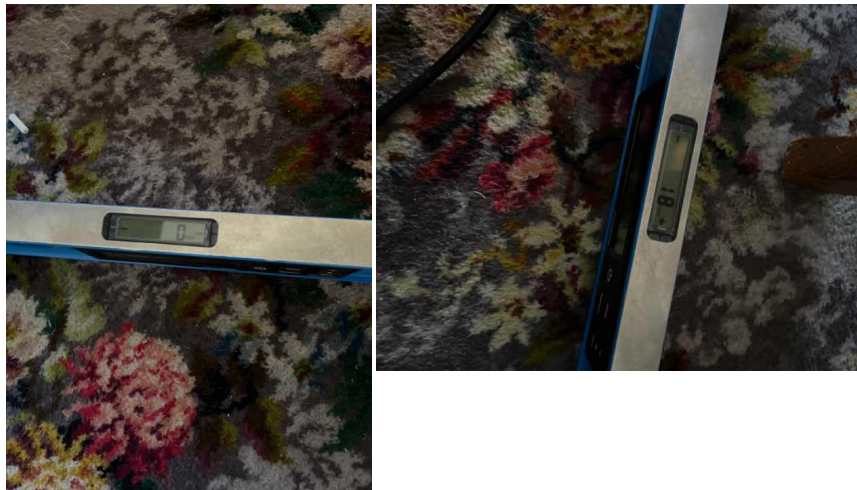
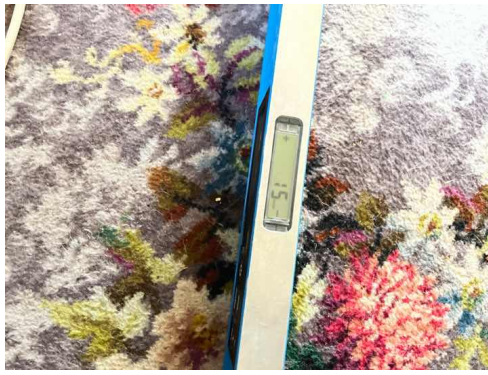
General age, deterioration or wear and tear to sections of the floor linings. General repair and maintenance advised.

Unevenness visible in sections of flooring - Possible causes - older homes have been re-stumped & not leveled adequately or could be some recent or past differential settlement in the footings. A qualified carpenter or stumping contractor should be engaged to assess immediately - homes levels & adjustments may be necessary.

Minor creaking in flooring sections - In some circumstances this can be due to workmanship, fixings loosened/deteriorated, dampness/rain during construction. A qualified carpenter should be engaged to ascertain cause & remedy.

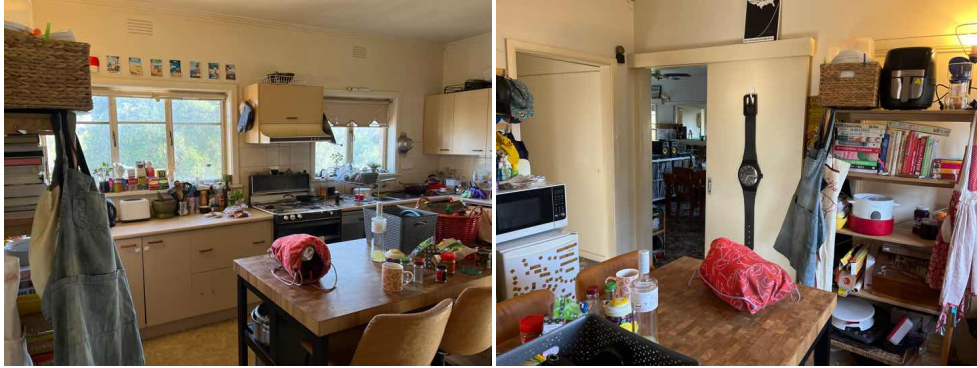
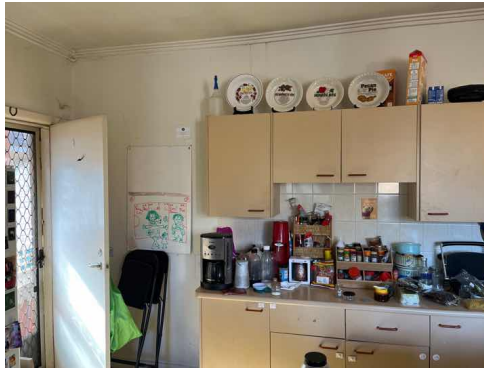
Bench top and splash back junction sealing deteriorated - Re-sealing by a plumber or general maintenance contractor is recommended to prevent water access behind the benches/vanity.
