# Inspection Report - Non Invasive

**Safehome PTY LTD**

**1 Smith St, Pennydale, VIC, 3192**

Report/Agreement #	2305230921506
Inspection Date:	23 May 2023
Inspection Time:	11:00 am

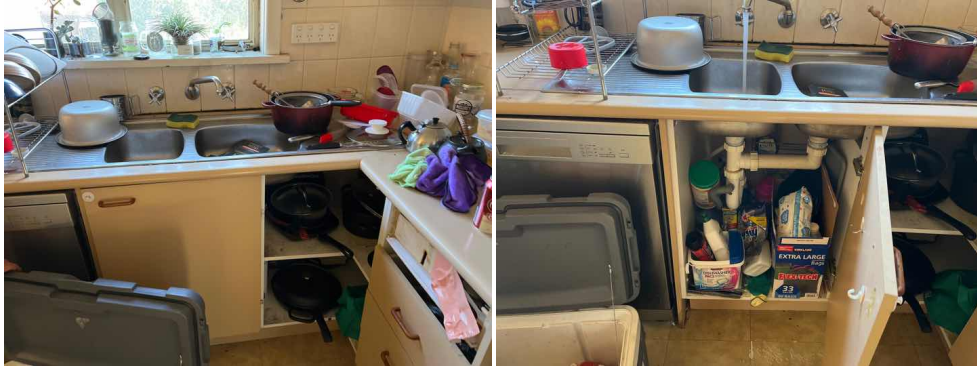
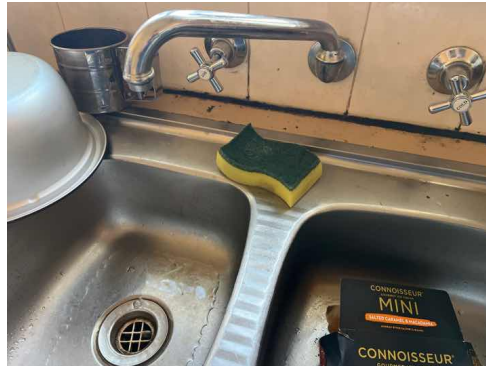
Cook top is loose. Have plumber re-fix.

Damaged areas of oven. Have repaired  
Mould in cupboard areas. Have professionally assessed and cleaned.

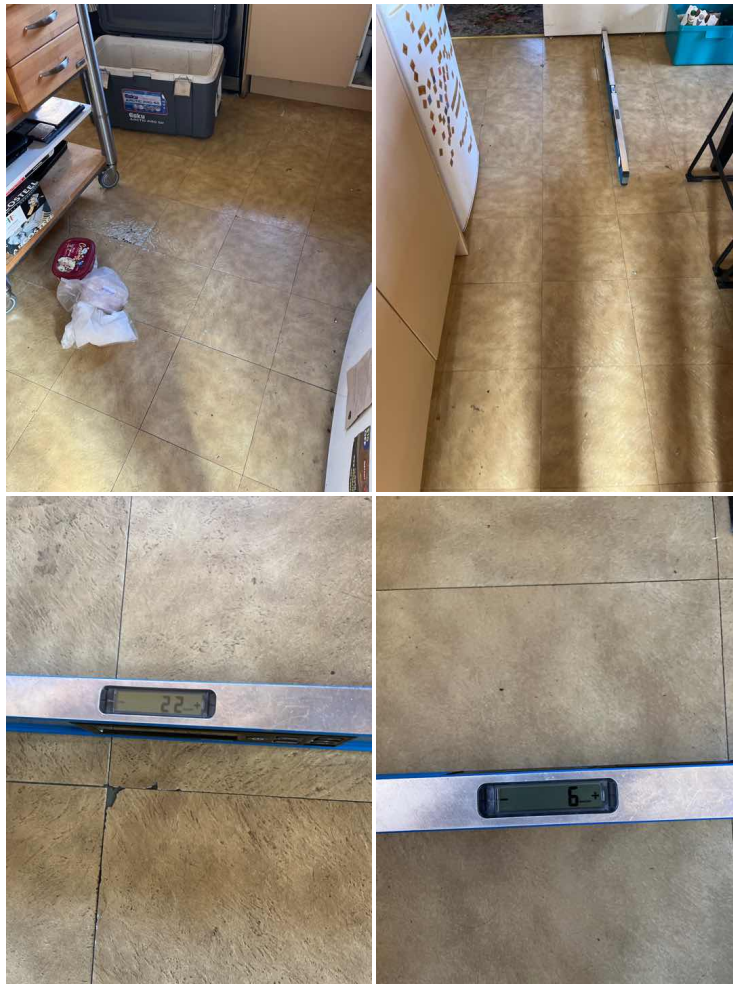
General age, deterioration or wear and tear to sections of the floor linings. General repair and maintenance advised.

Minor creaking in flooring sections - In some circumstances this can be due to workmanship and/or fixings loosened, deteriorated, dampness/rain during construction. A qualified carpenter should be engaged to ascertain cause & remedy.

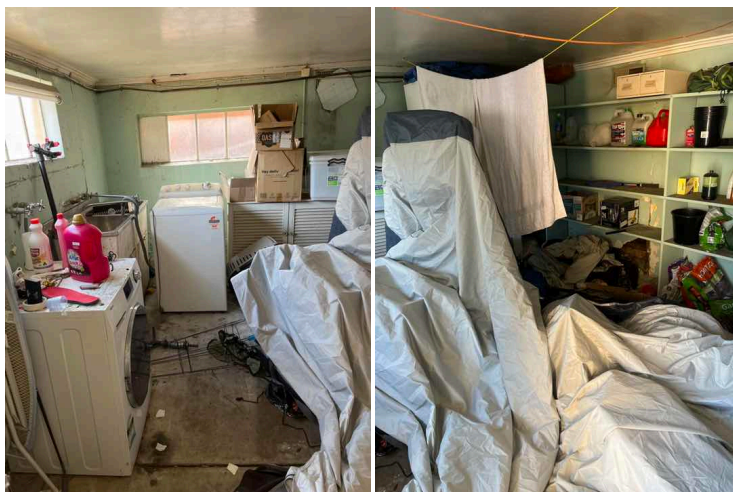
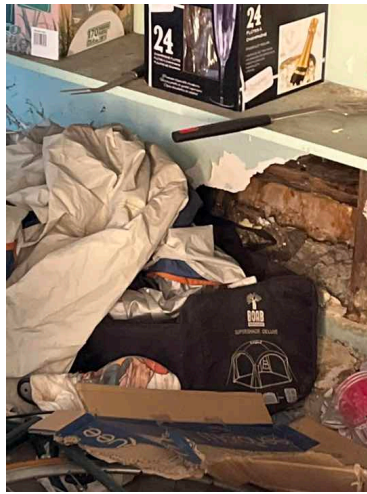
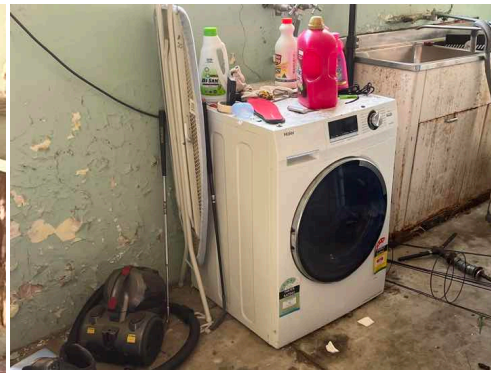
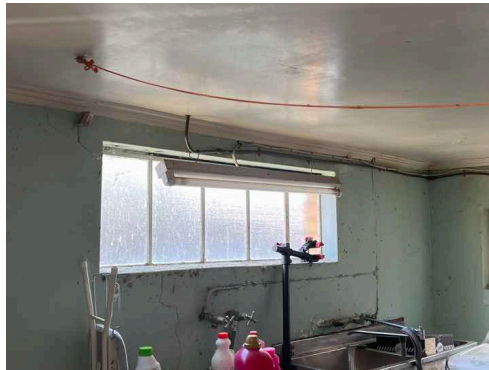
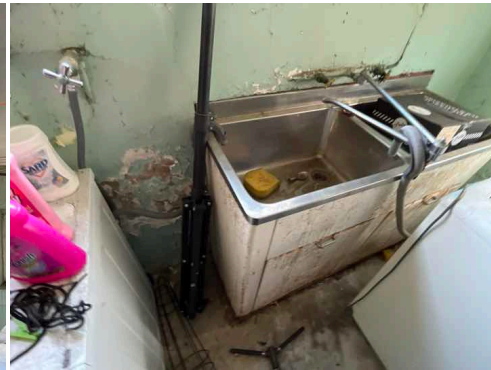
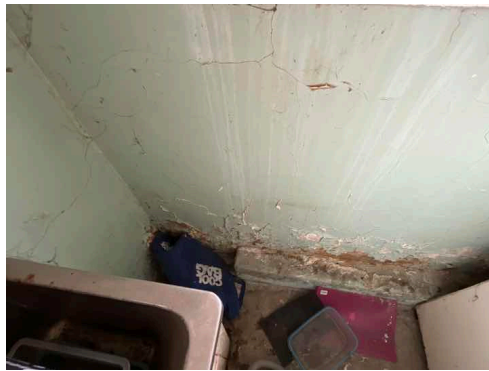
There maybe damage to timber wall frame behind this wall.

Old floor staining visible. Typically caused by past leaks.

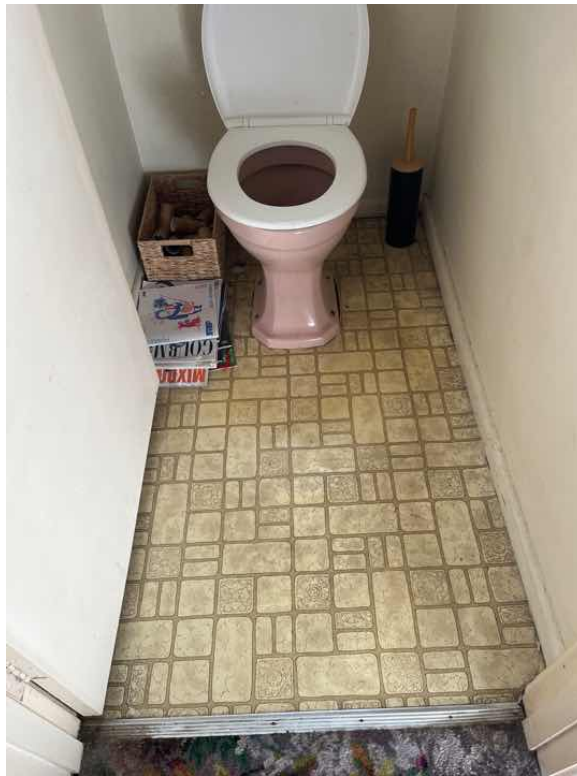
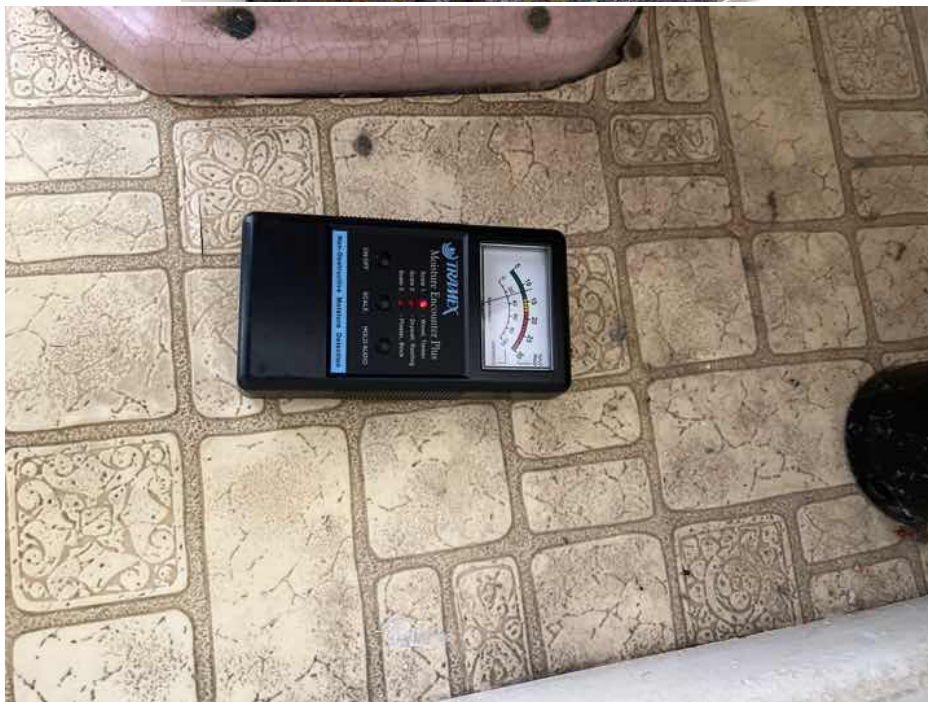
General age, deterioration or wear and tear to sections of the floor linings. General repair and maintenance advised.

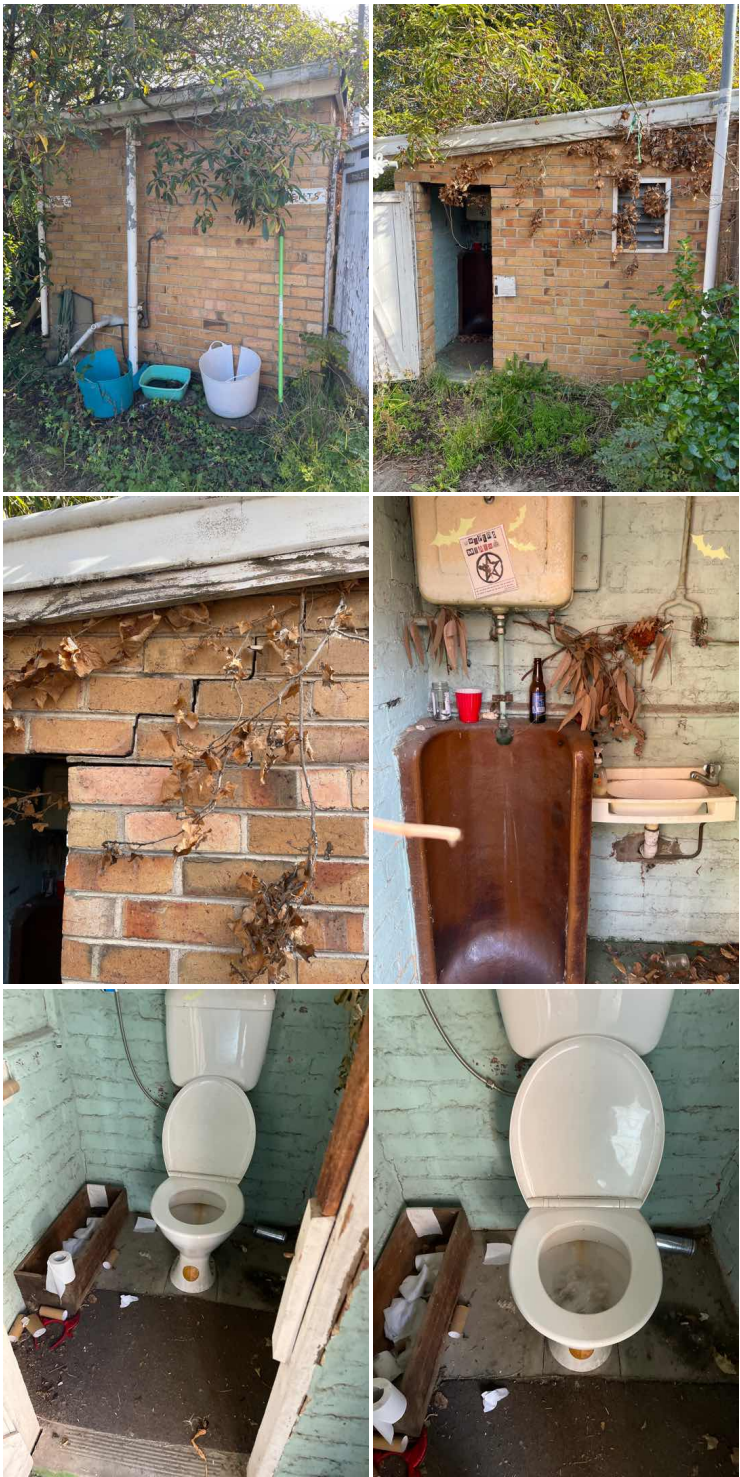
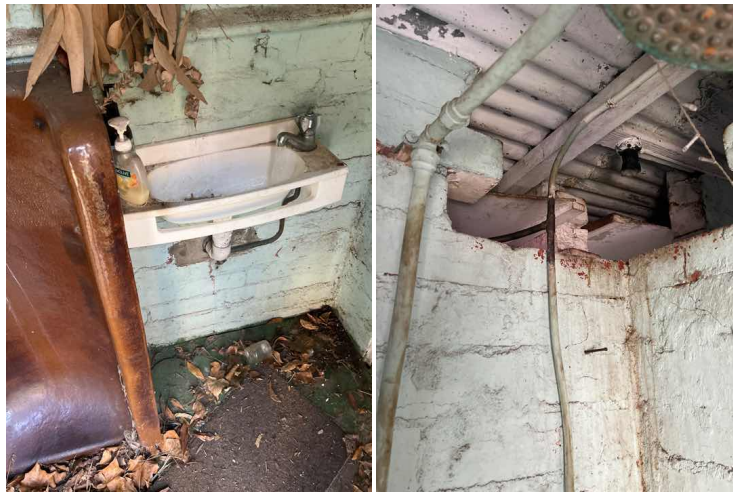
## **SEPARATE TOILET(1).**

On inspection, defects were present that will require further assessing and recommendations by licensed and qualified trades persons, please read below for details.

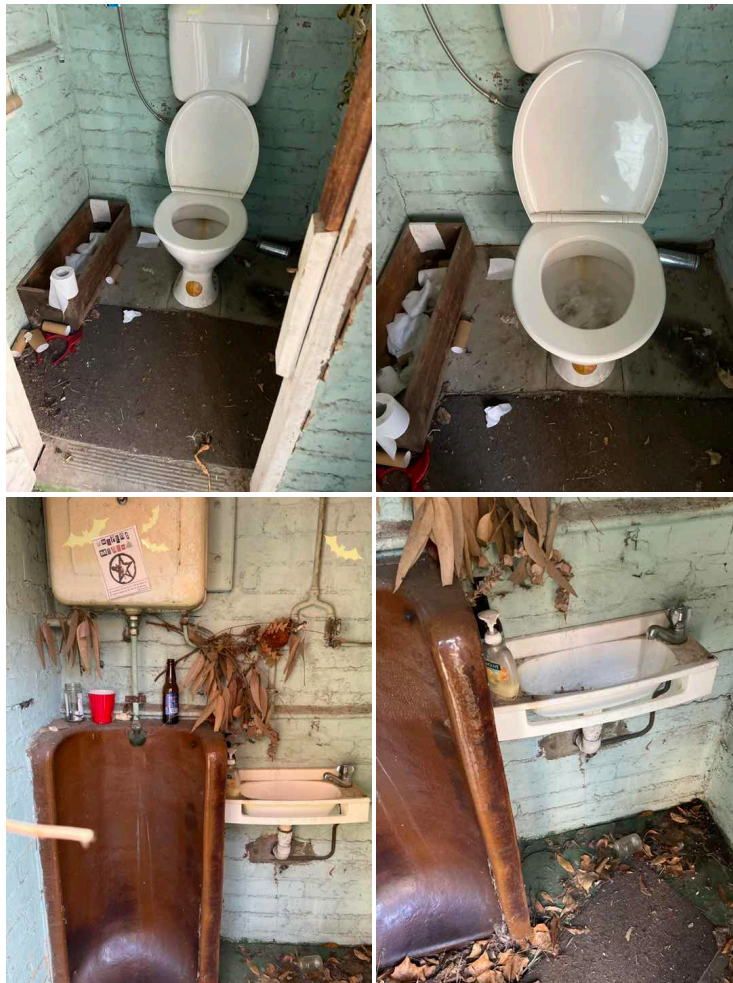
No visible evidence of excess moisture emanating through to surrounding walls or skirting board from toilet leaks.  
No excess moisture readings obtained.

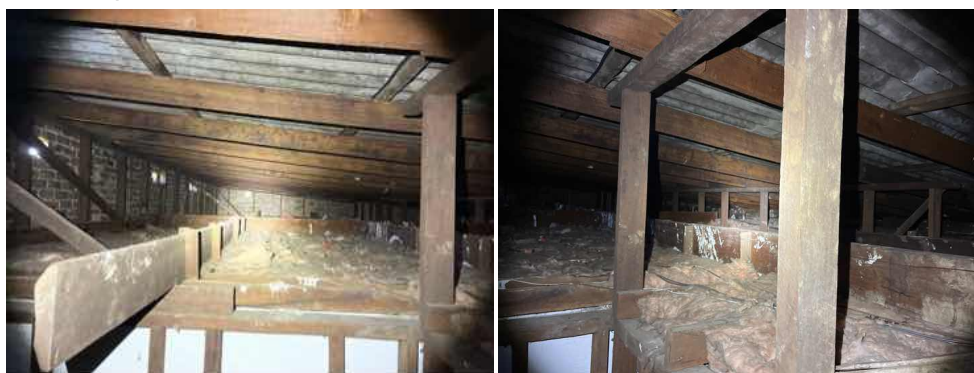
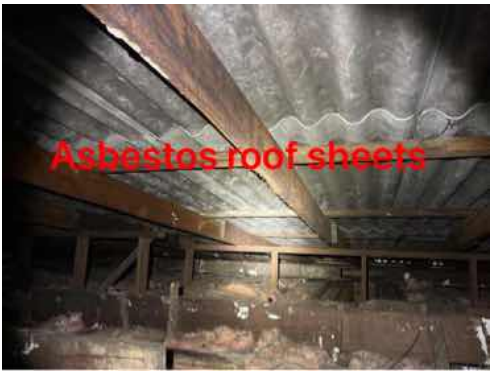
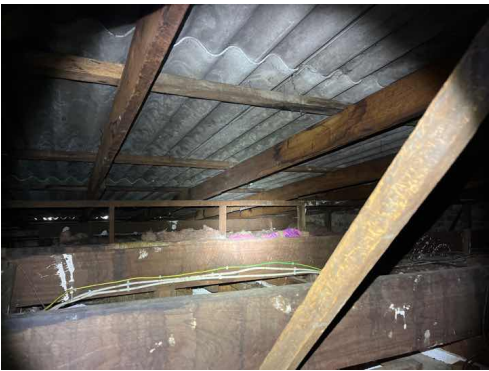
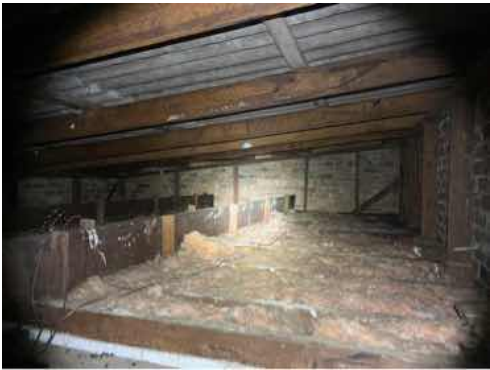
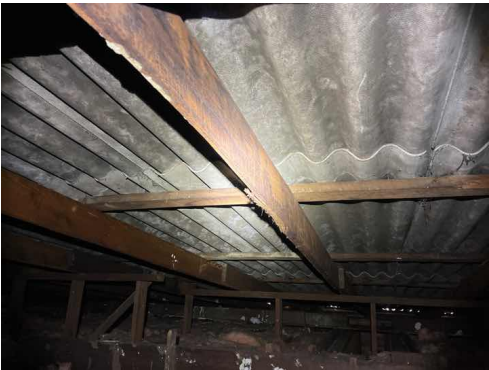
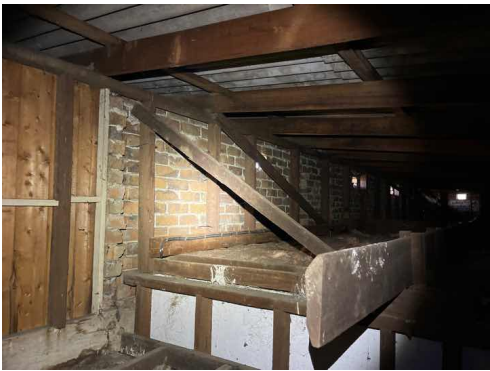
A view only from the man hole was made. See Areas Obstructed / Restricted / Not Accessed for details. On inspection, defects were present that will require further assessing and recommendations by licensed and qualified trades persons, please read below for details.

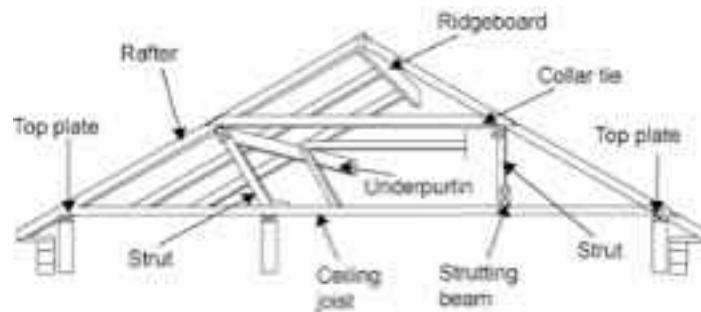
The roof frame is a conventional timber frame.

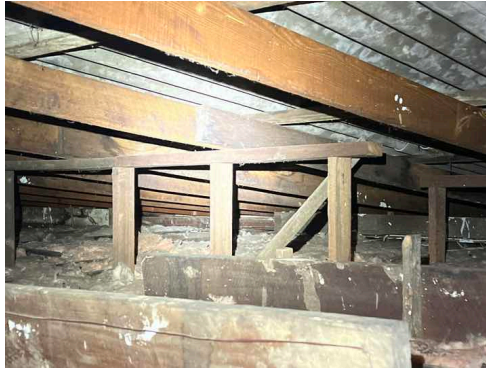
The strutting of the roofing is considered inadequate/poorly fixed - Engage a qualified Carpenter to assess.

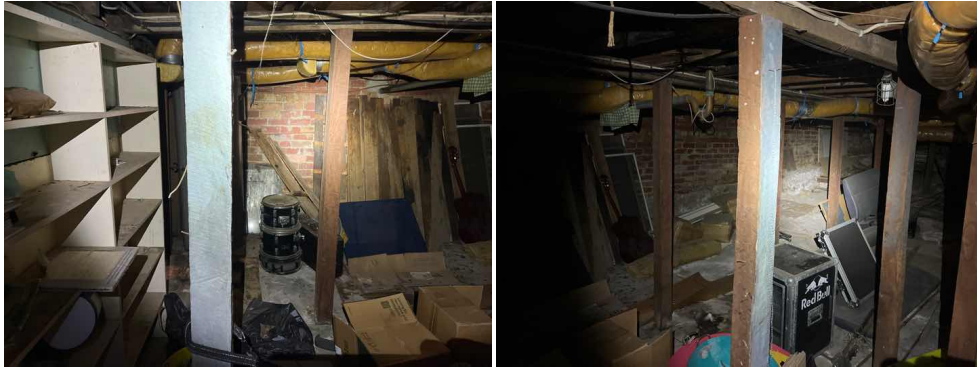
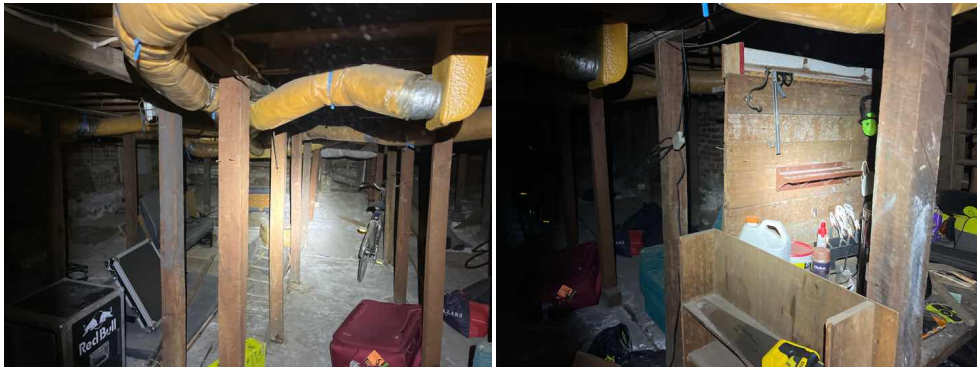
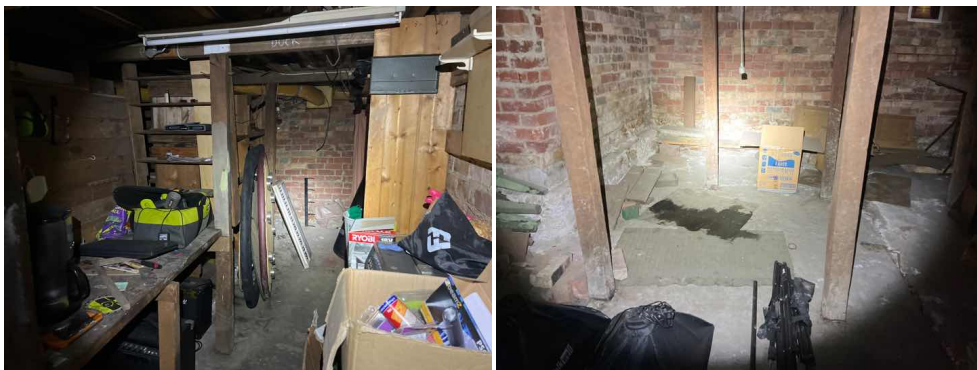
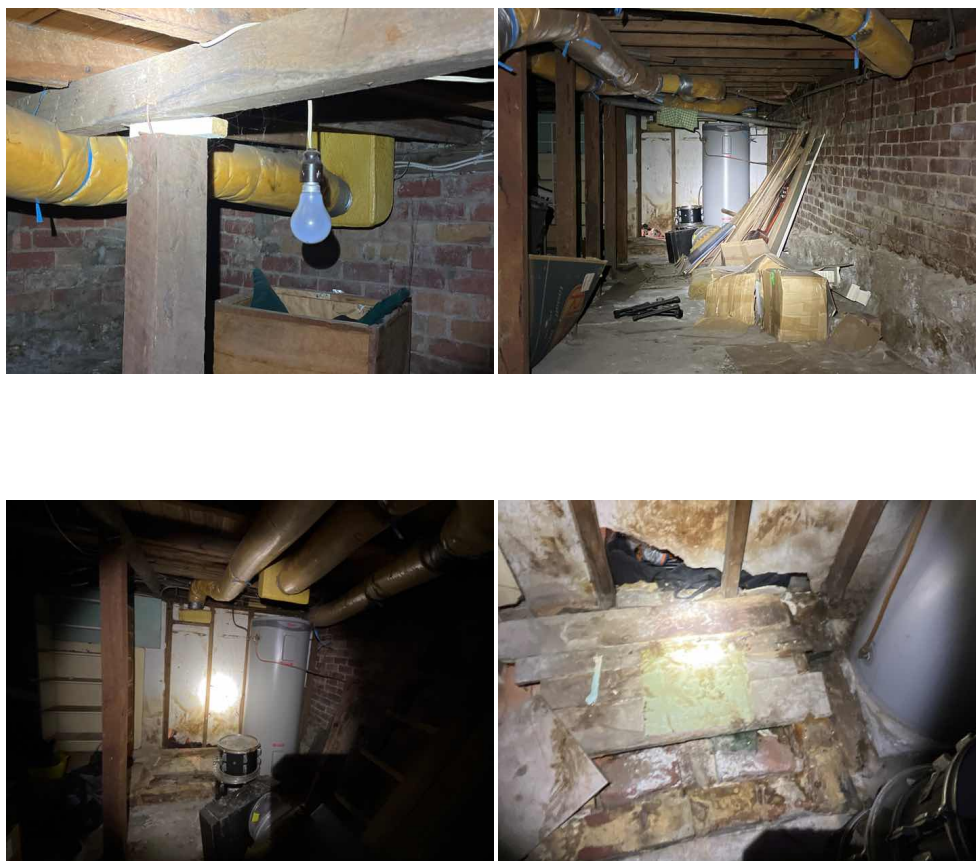
On inspection, defects were present that will require further assessing or repairs.

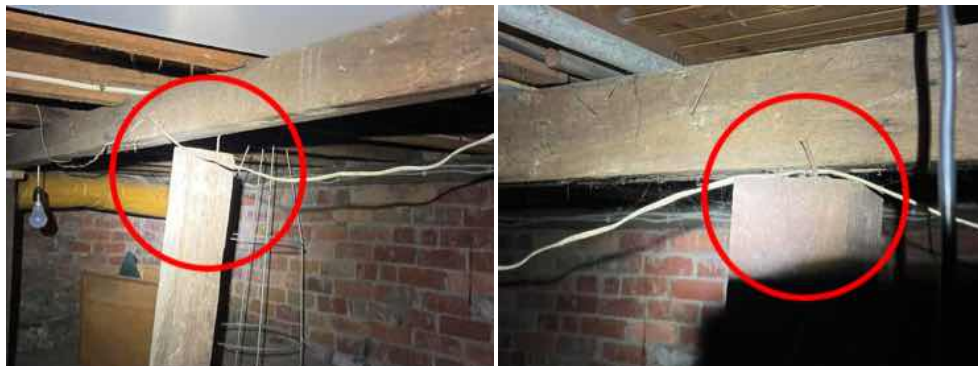
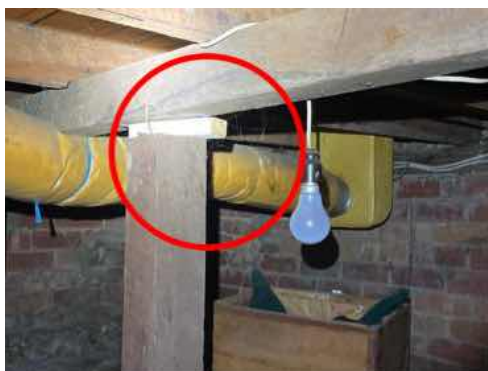
Excessive or inadequate packing between bearers & stumps/piers - If the sub floor is kept dry this should not be too much of an issue, however packing is defective if it is compressible such as timber packing. A qualified re-stumping contractor should be engaged for advice & recommendations.

Excessive packing between bearer and stump top -Section 4.04 of the Guide to Tolerances and Standards - Packing to stumps or piers under bearers is defective if it is not made of durable, non-compressible materials, such as engineered plastic packers, or does not provide the minimum bearing area required by AS 1684, is more than a total thickness of 20 mm, or is not fixed in a proper and workmanlike manner.

Stumps are not supporting bearers in Sections - Engage a qualified re-stumping contractor for advice & recommendations. May be due to settlement in footing/stump decay or poor workmanship. Sometimes rectification is by packing to prevent "Bounce" in floor areas.

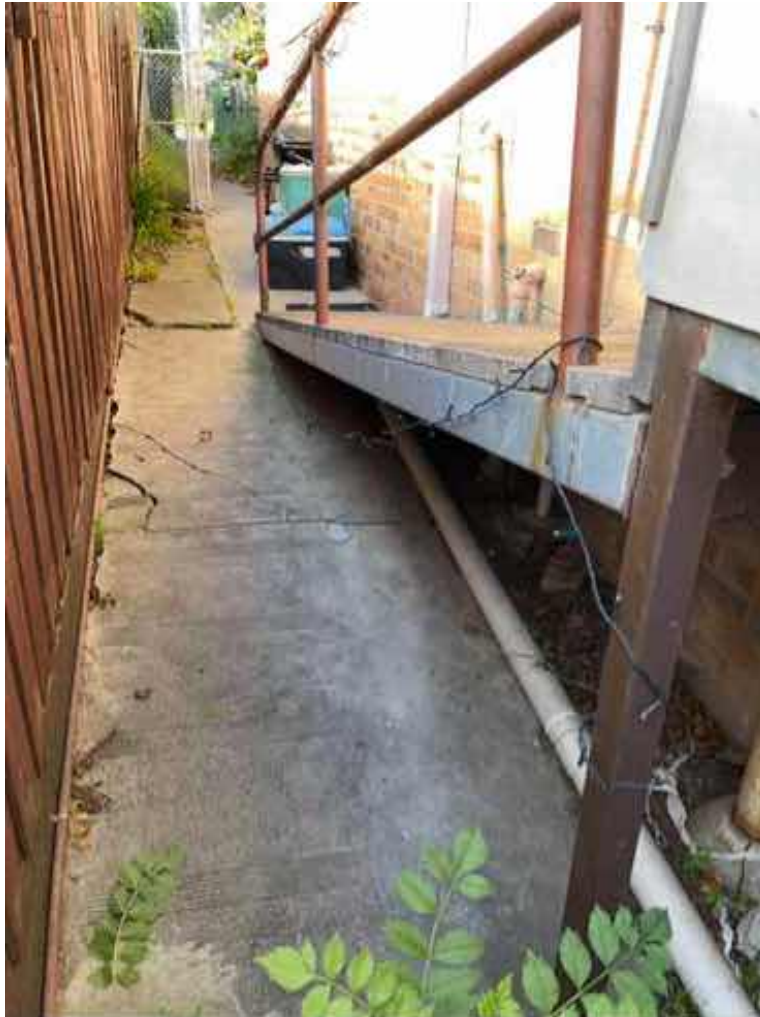
On inspection, defects were noted that may require further assessment and recommendations by licensed tradesman.
